# Your survey report

**Property address**

Level 2 Sample Report

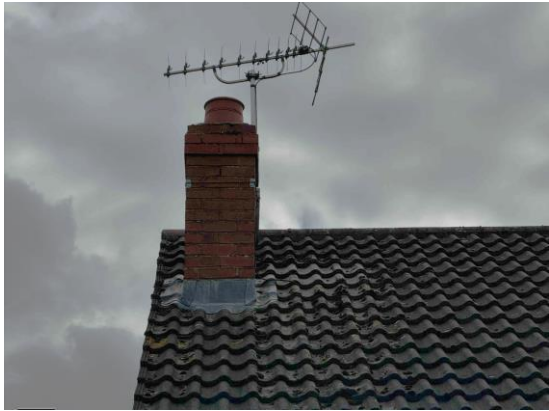
Chimney stack

The chimney stack is in reasonable condition bearing in mind the age of the property. No signs of any significant bulging, lean or outward movement was noted. No signs of leakage or excessive weathering was noted. The flashings appear to be adequately dressed to the roof covering and pointed into the masonry.

Over time deterioration to the chimney stack will occur because the various parts, including the flaunching's and flashings are very exposed. Chimney stacks should be regularly inspected and maintained in good condition. When carrying out remedial works, any hidden parts should be checked to ensure no additional disrepair has occurred.

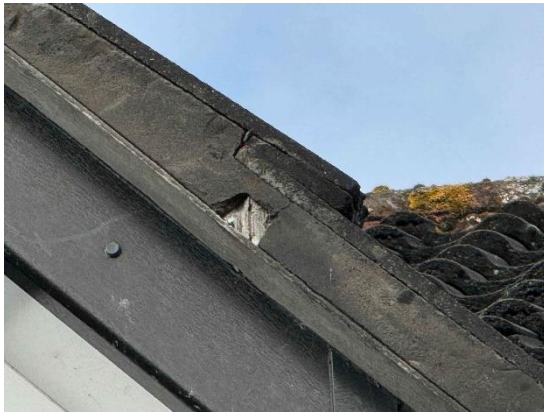
- There is moss growth on the main roof covering. If loosened by heavy rain, moss can roll into the guttering and cause blockages. It should be carefully removed to reduce this risk.
- Some of the mortar pointing to the roof verges is cracked and starting to loosen. Re-pointing is required to reduce further deterioration and water ingress.
- Vegetation was observed growing between the ridge tiles. The vegetation should be removed, and the joints repointed to prevent moisture ingress and potential damage to the roof structure.
- Open mortar joints were noted around the flashings, most notably to the front elevation. These joints should be repointed to ensure a proper seal and prevent water penetration.
- The valley gutters are partially blocked with debris. These should be cleared to prevent blockages and water ingress.

Cracked verge pointing

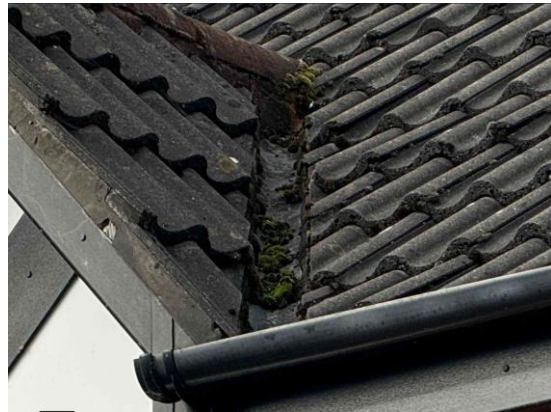
Valley gutters are vulnerable locations for damp penetration. Some of the timbers beneath the valley gutters were noted to be discoloured when viewed from the roof space but no signs of active water ingress was noted. As part of your future maintenance of the property, regular inspection should be undertaken in order to ensure their condition remains satisfactory.

Partially blocked valley gutters

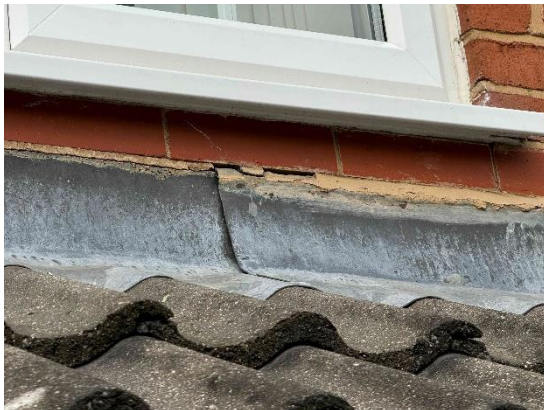
Open mortar joints

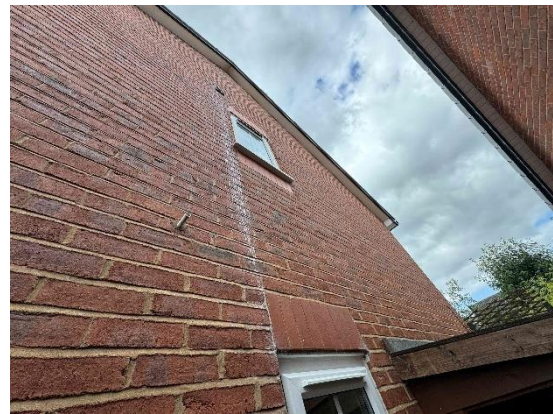
- Efflorescence is visible on the right-hand side wall surface, identified by white staining. This is caused by the accumulation of naturally occurring salts in the bricks, resulting from moisture within the brickwork. In this instance, it appears to be due to condensation and water run-off from the extractor vent above. The efflorescence does not cause any significant damage to the brickwork, and these deposits will gradually dissipate over time. If immediate removal is desired, dry brushing can be employed, taking care not to scour or damage the brickwork surface.
- Some of the weep holes were noted to be blocked. These should be cleared to allow proper drainage and prevent potential damp issues in the surrounding masonry.
- A gap was noted in the brickwork mortar joint on the left-hand side elevation. The mortar should be repointed to prevent water ingress

Efflorescence in the form of white staining

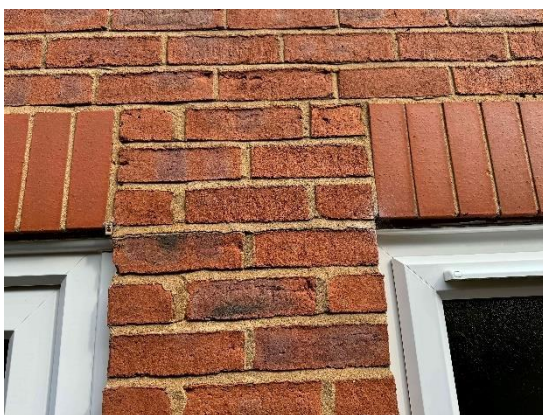
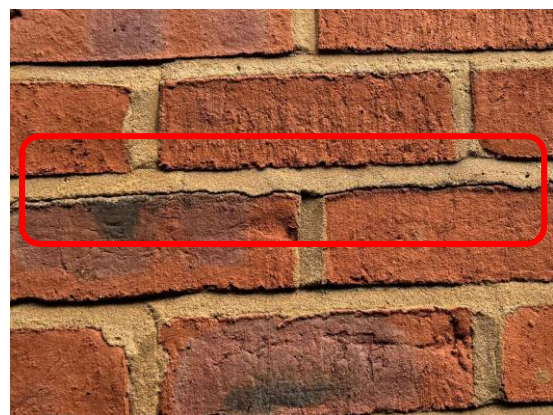
A hairline crack was observed along the mortar joint above the downstairs WC window. Currently, this is not considered significant; however, future repairs cannot be ruled out. These repairs may involve the installation of stainless steel reinforcing bars in the mortar joints above the opening. For the time being, it is recommended to monitor the situation. However, please be aware that remedial works may be required during your future occupation of the property.

Hairline crack in the mortar joint where the lintel is positioned

Close-up of hairline crack

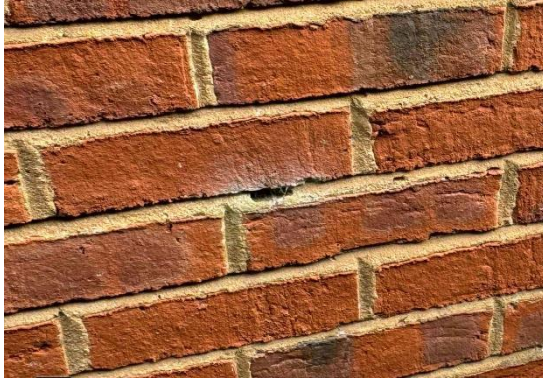
Gap in mortar joint

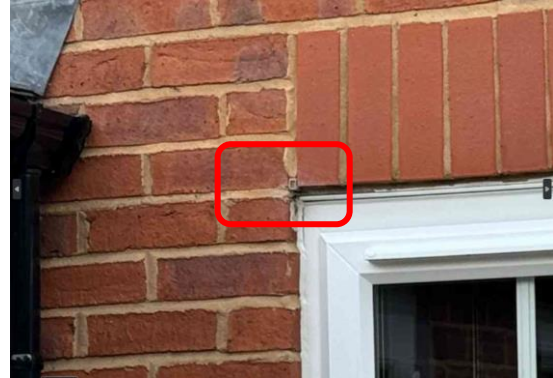
Blocked weep hole

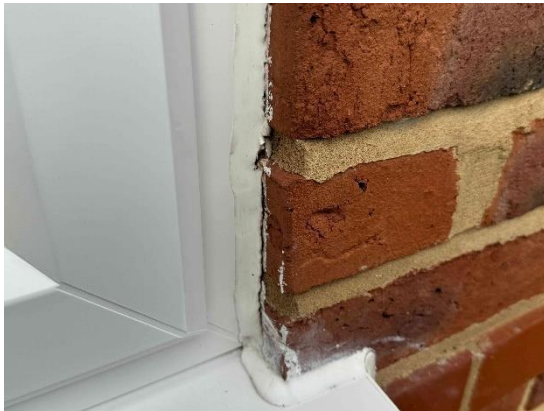
There are some small cracks in the sealant between the window frames and the surrounding masonry, but I noted no damp internally as a result. In time the sealants will need to be replaced as part of normal maintenance to reduce the risk of water ingress and damp.

Small gaps in sealant

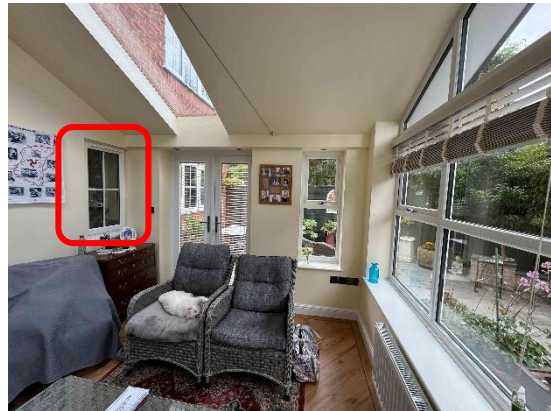
The window in the lounge opens into the extension. While this is not a defect, it is something you may wish to be aware of.

Window in lounge opens into extension

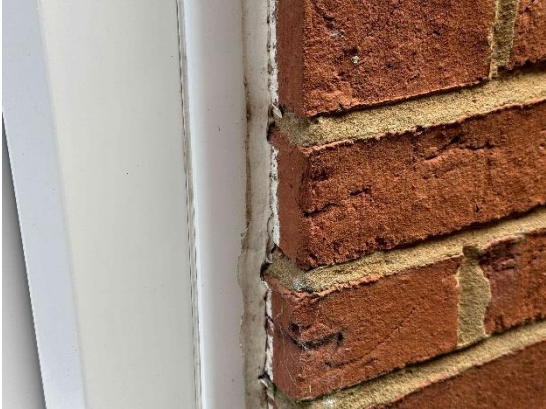
There are some small cracks in the sealant / mortar pointing between the door frames and the surrounding masonry but I noted no damp internally as a result. In time the sealants / pointing will need to be replaced as part of normal maintenance to reduce the risk of water ingress and damp. Normal maintenance will be required.

| Front door | Small gaps in sealant | |

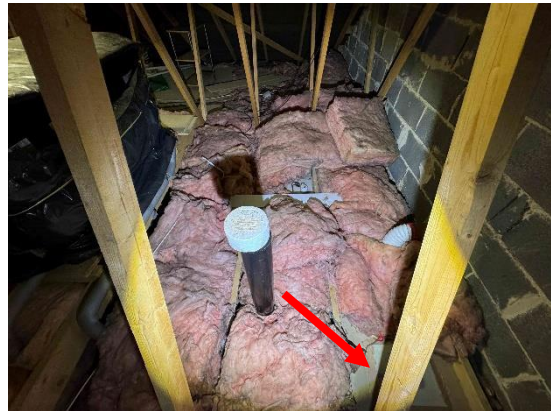
- The insulation levels in the main roof are below current standards, with gaps that may result in cold bridging and reduced thermal efficiency. It is recommended to improve the insulation. Care must be taken during the upgrade to avoid obstructing ventilation or covering electrical cables within the roof space.

Insulation laid to approximately 150mm thickness but gaps are present

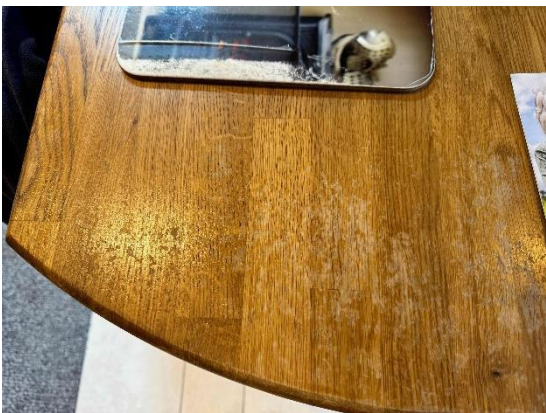
Wear and tear to fittings

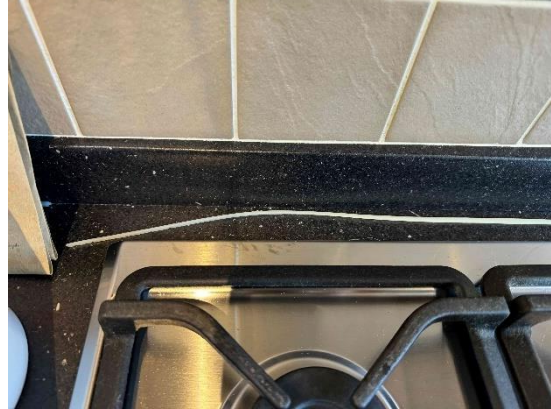
- The seals to the worktops are loose. This could allow water to seep past and cause damage to adjacent surfaces and should be replaced.

Loose seals

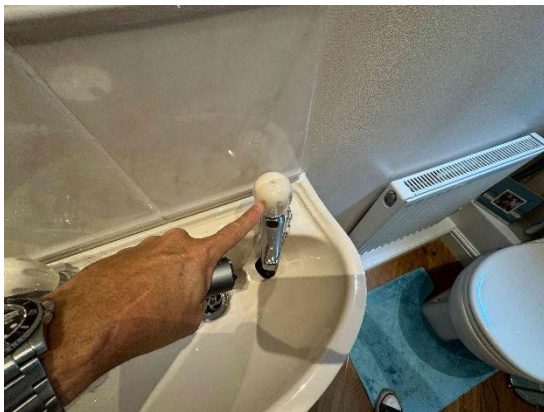
Taps in downstairs WC were found to be loose

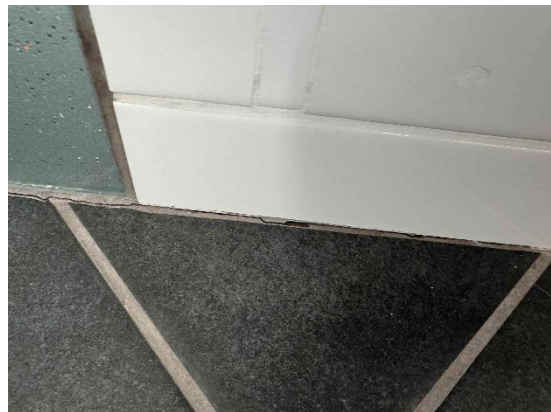
Grout is deteriorating

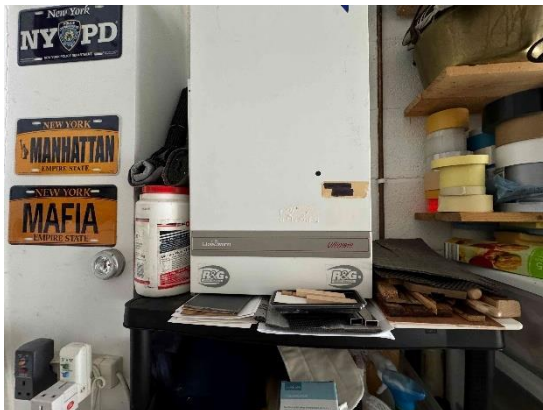
It should be noted that, although a test of the boiler system is available, the system is outdated and will require replacement during your future occupation of the property. This is likely to include the replacement of radiators. It may also be advisable to consider upgrading to a combination boiler at this time, which would allow for the removal of the water storage tanks. It is advisable to obtain quotations for these works prior to the purchase in order to budget appropriately.

Boiler in garage is dated

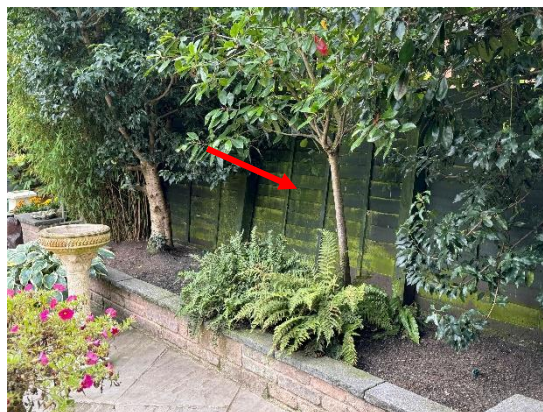
Leaning fence

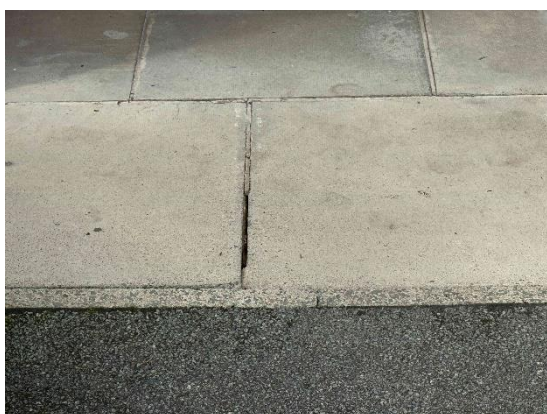
Gaps between paving slaps
