LEVEL 3

# Your survey report

Level 3 Sample Report

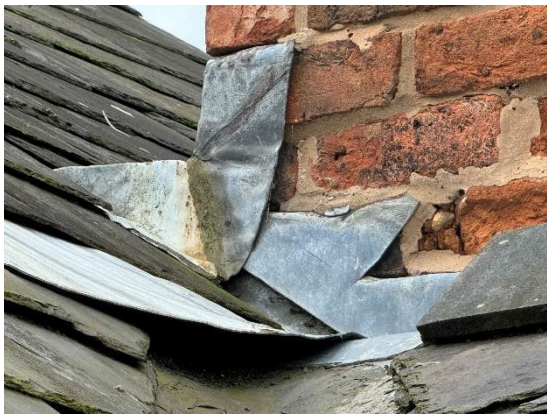
Loose flashings and gaps over and around flashings

The chimney stacks should be repaired including replacement of all flashings, flaunching's and weathered bricks.

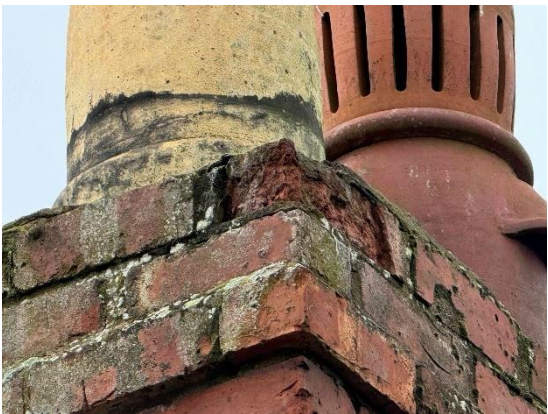
Weathered masonry

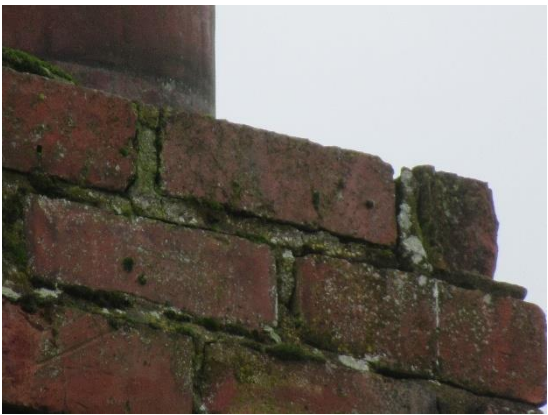
Missing flaunching (top) and perished / loose mortar pointing

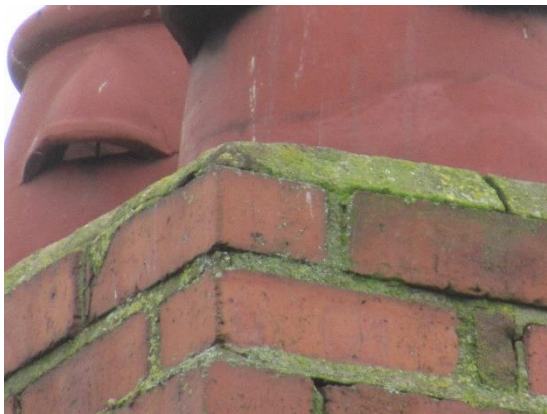
Cracked mortar flaunching

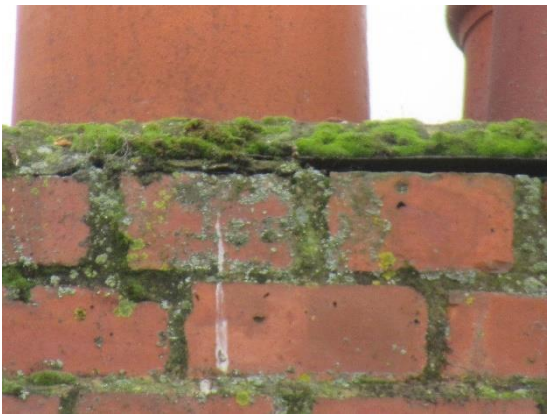
Loose mortar flaunching

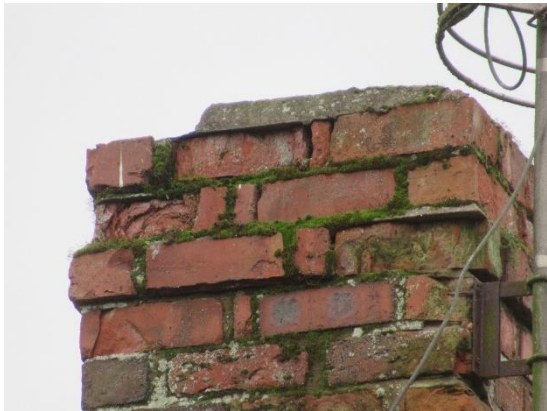
Weathered masonry, perished mortar pointing and missing flaunching

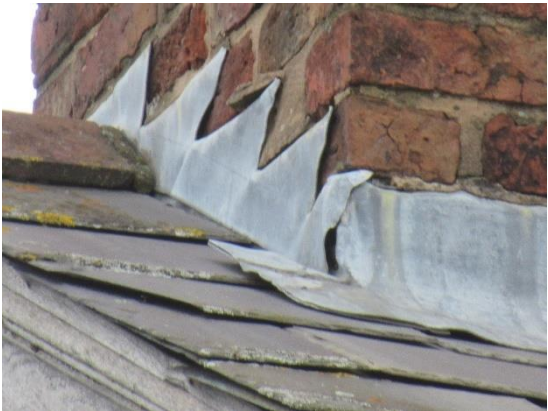
Splits in flashings and loose mortar pointing

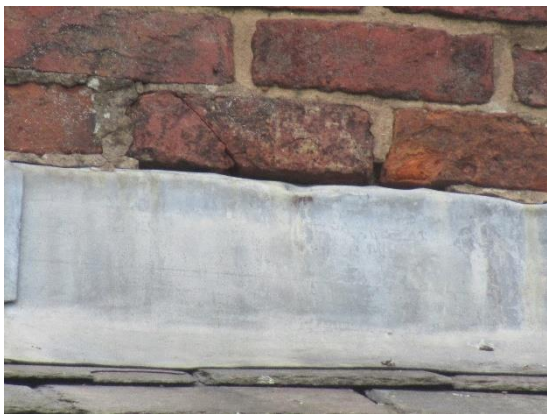
Gaps over flashings

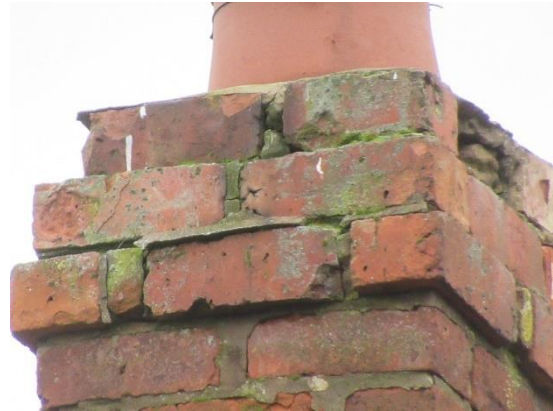
Weathered masonry, perished mortar pointing, loose mortar pointing and loose flashing

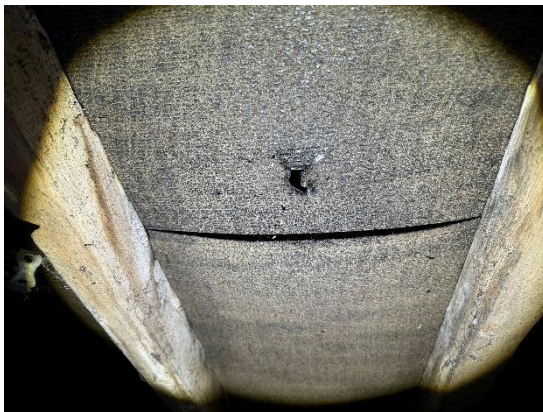
- The underlay (viewed from the internal roof space) is torn and damaged in places and this increases the risk of water ingress in severe conditions. This will prevent the efficient discharge of surface water should it penetrate the roof covering. The damaged sections should be patch repaired.

Damaged underlay to main section

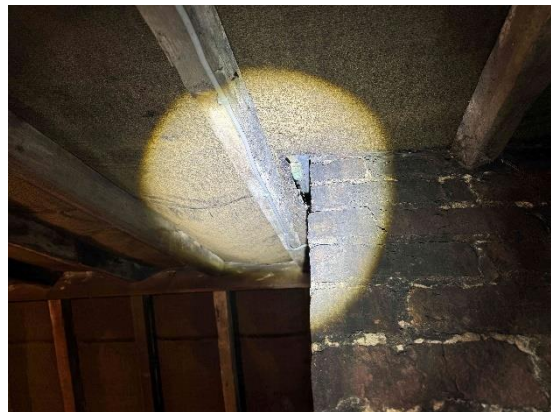
Damaged underlay to main section

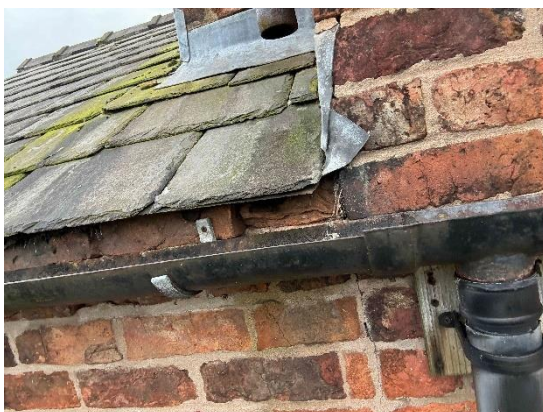
Underlay not lapping into gutter

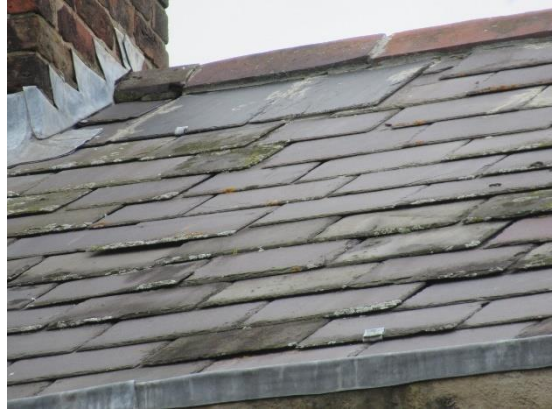
- Some of the slates to the front slope have been replaced with the incorrect sized slates. This may be non-compliant with Listed Building regulations and may need to be changed.

Incorrect sized replacement slates installed

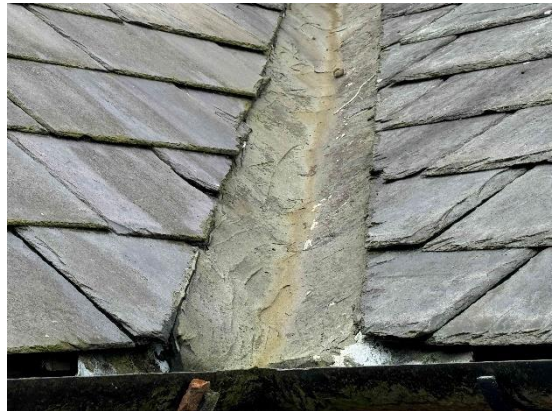
- High damp meter readings were taken internally within the bathroom located beneath the valley gutter which has been repaired in a DIY nature. The roof covering should be stripped back in the area and replaced.

DIY repair to rear valley gutter

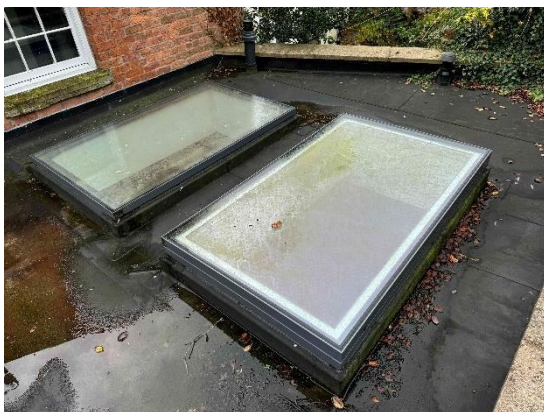
Rear extension roof

- The roof is leaking or has leaked previously, evident by water staining noted to the ceiling and wall finishes internally. The roof covering should be closely inspected by a specialist flat roofing contractor and repaired where required. Vegetation growth should also be removed to allow for a thorough inspection.

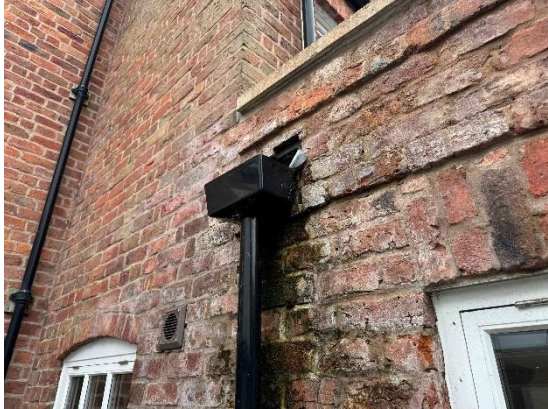
| Gaps between coping stones | Inadequate hopper detail leading to water ingress in hallway |

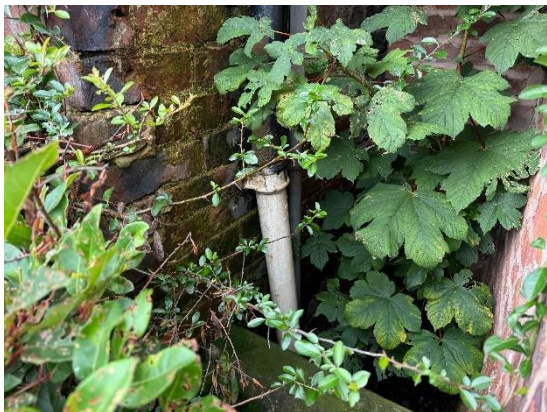
Loose downpipe likely discharging into the right hand side landscape leading to damp internally

- The downpipe to the right hand side is loose and likely discharging into the right hand side landscape leading to damp internally. The downpipe should be secured and altered to ensure it drains away from the landscape / property or into a gully.

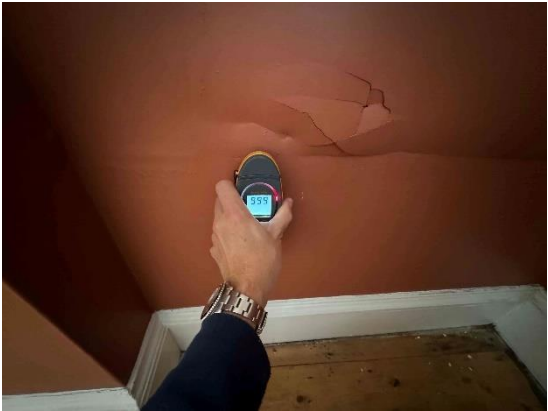
- Evidence of damp and high damp meter readings was found throughout the property. The pattern of damp would indicate the most likely cause to be a result of:-
  - a lack of an effective damp-proof course,
  - the original solid floors not containing a damp proof membrane,
  - the damp proof course (if present) being bridged by the landscape and garden walls,
  - condensation and trapped moisture within the floor void,
  - the perished mortar pointing to the walls,
  - the defective rainwater downpipe to the right hand side elevation,
  - the inadequate flashings to the conservatory,
  - the gaps around the window openings,
  - and trapped moisture within the walls / plaster.

High damp meter readings and damaged plaster at ground floor level

All of the affected plaster should be removed and repairs undertaken to rectify the cause of the damp. Once removed the masonry should be allowed to dry out.

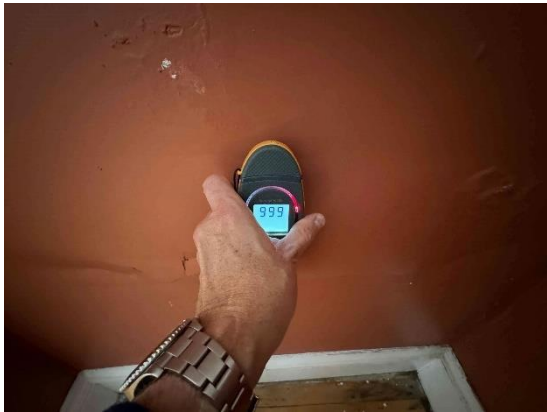
High damp meter readings and damaged plaster at ground floor level

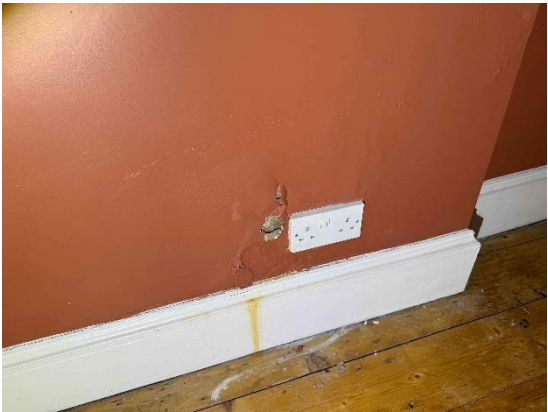
Damaged plaster at ground floor level

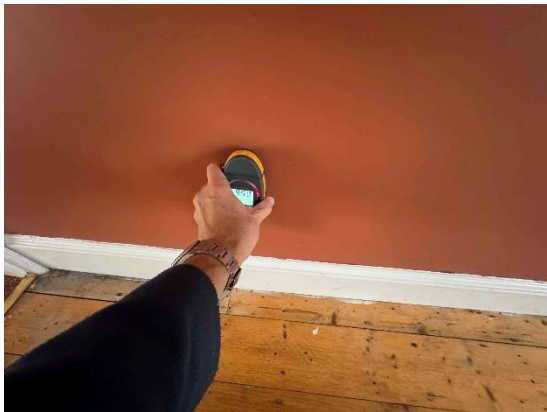
High damp meter readings at ground floor level

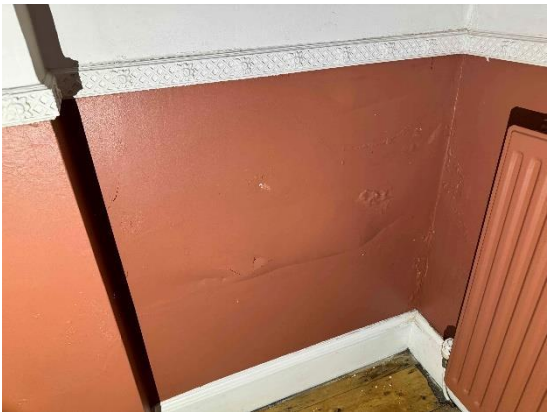
Damaged plaster at ground floor level

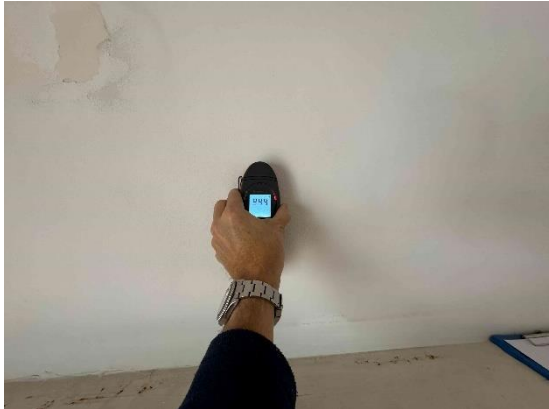
High damp meter readings and damaged plaster at ground floor level

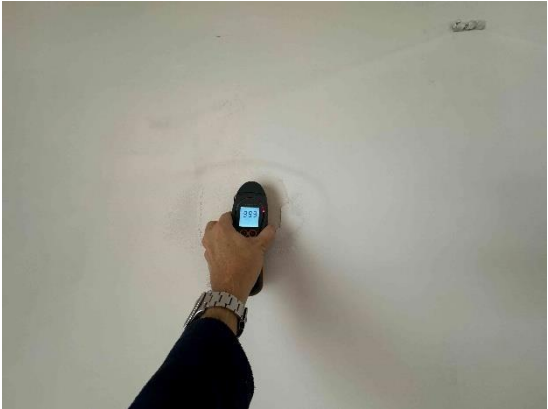
High damp meter readings and damaged plaster at ground floor level

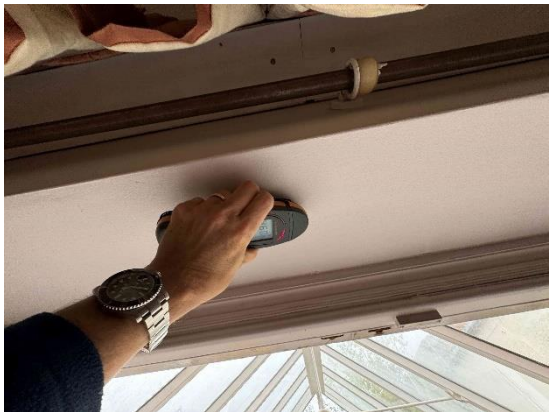
High damp meter readings at ground floor level

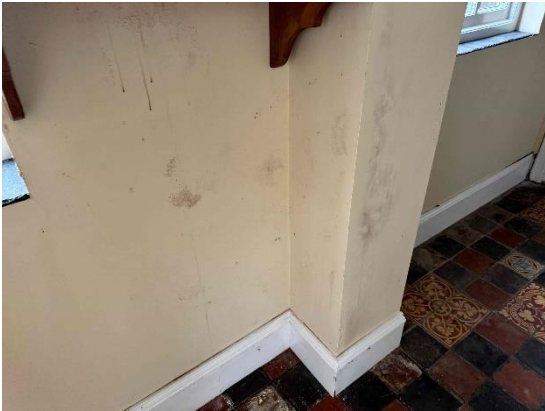
Damp plaster at ground floor level

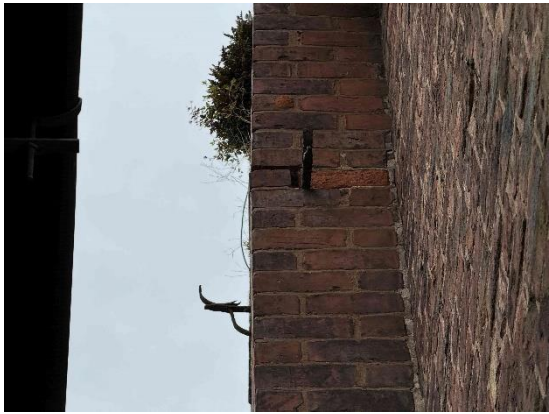
Movement noted to the right hand side wall / chimney breast

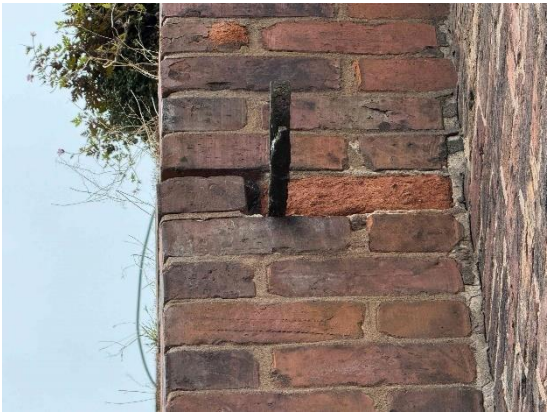
Movement noted to the right hand side wall / chimney breast

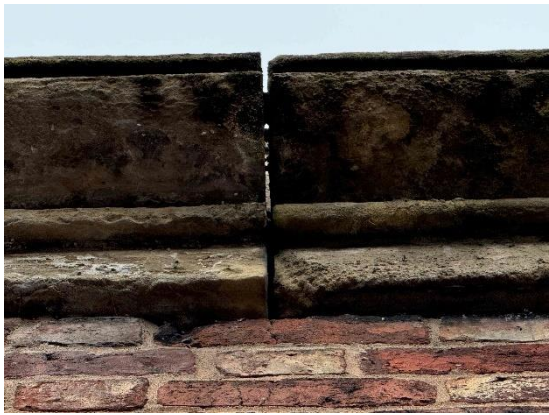
- The mortar pointing has perished in places and is missing around some service penetrations. Localised re-pointing is required.
- Some of the stonework is weathered with gaps noted between stones. All affected masonry should be repaired and the gaps sealed.

Gap in stonework and weathered stonework

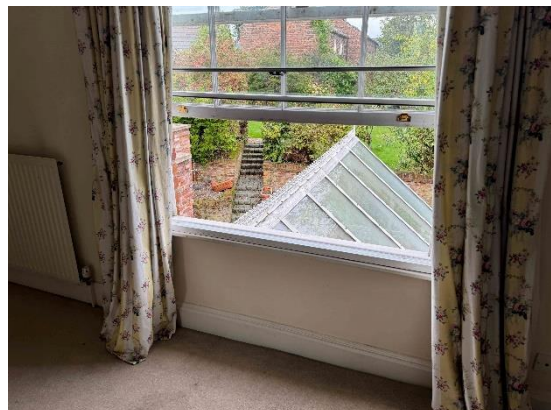
Safety concern with opening

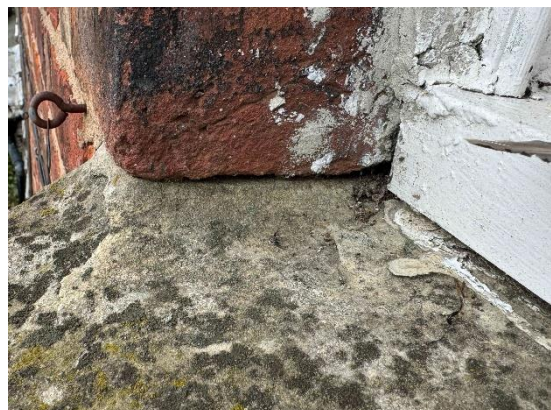
Gaps between frame and wall

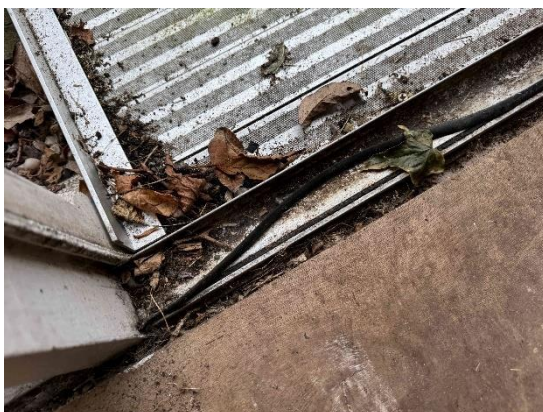
Loose draught strips to rear door

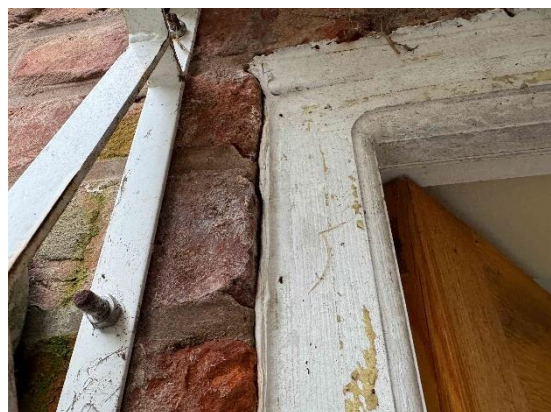
Gaps around rear door frame

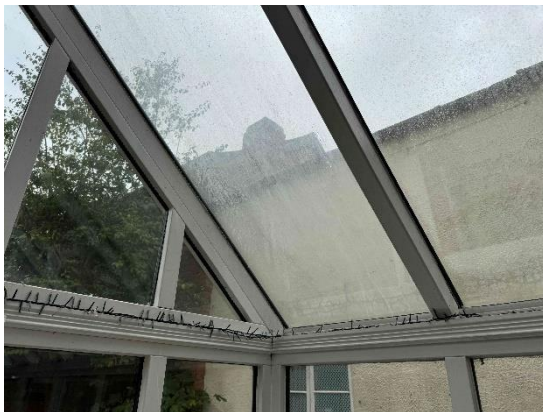
Misted glazing

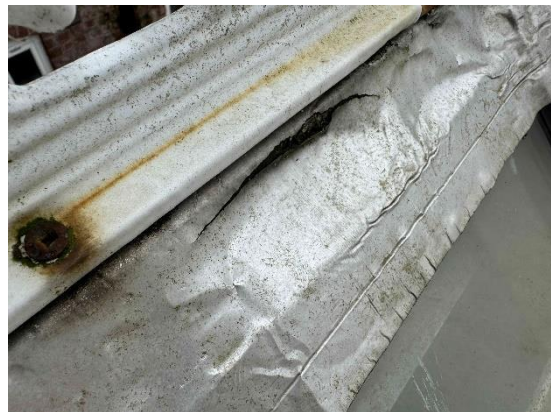
DIY self-adhesive repair with split

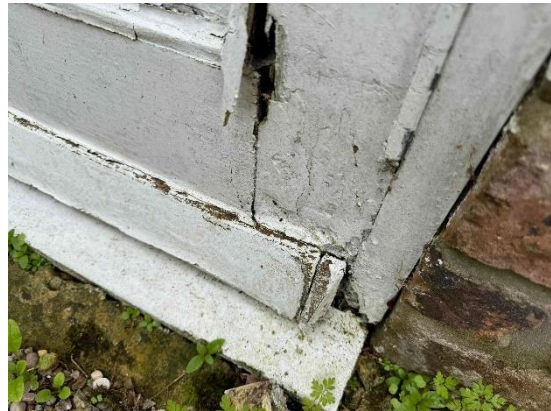
Decay to conservatory

Replace the conservatory.

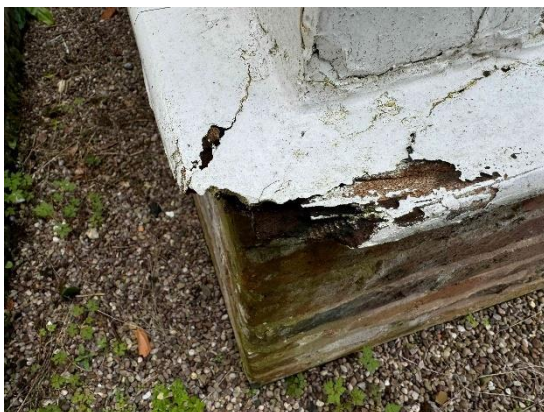
Decay to conservatory

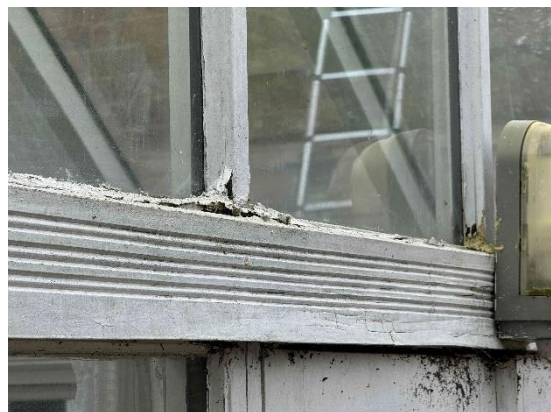
Decay to conservatory

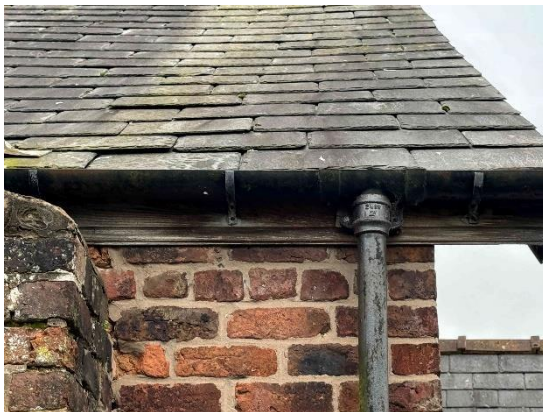
Weathered decorations

External decorations will need regular redecoration, typically on a three-to-five-year cycle dependent upon the quality of paint or stain coating. This should include all timber windows and doors.

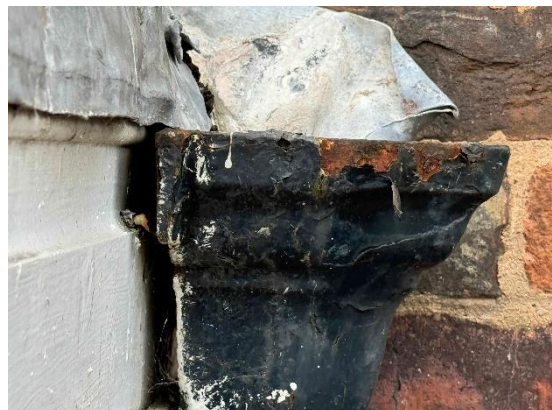
Flashings don't lap correctly into the hopper and loose / corroded hopper

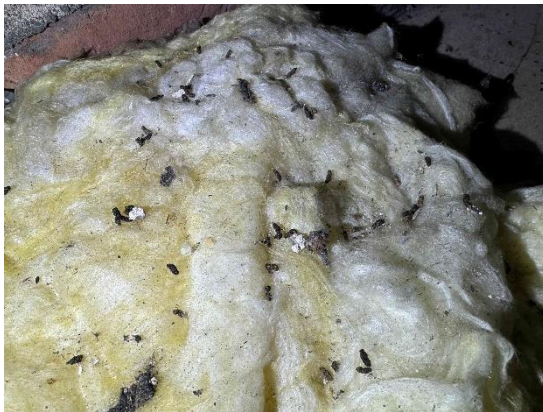
Evidence that rodents are or have been in the main roof space

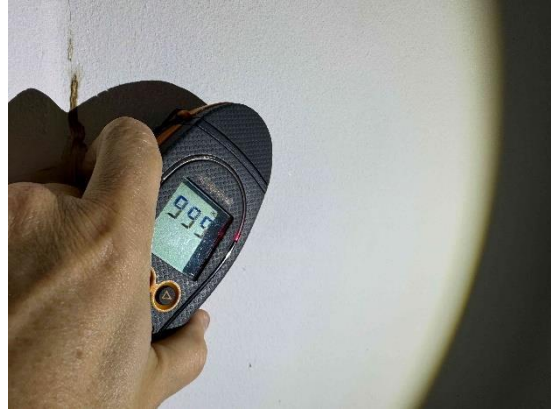
Staining to ceiling in bathroom found to be damp

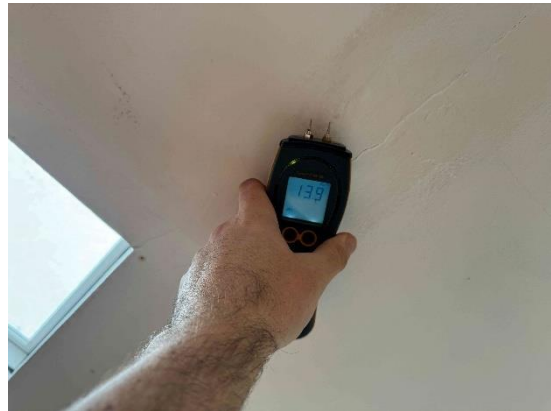
Staining to kitchen ceiling found to be dry

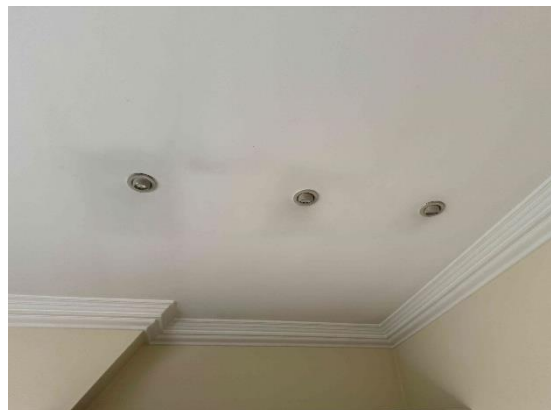
Black staining

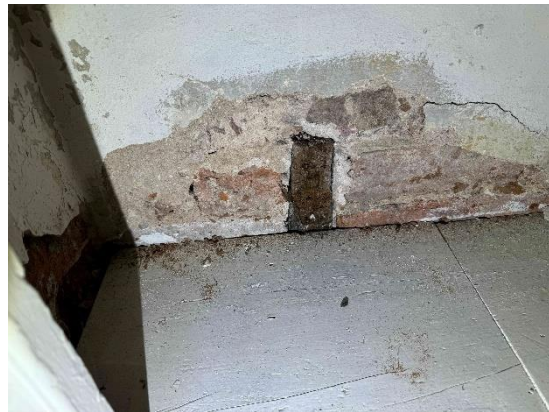
Missing plaster

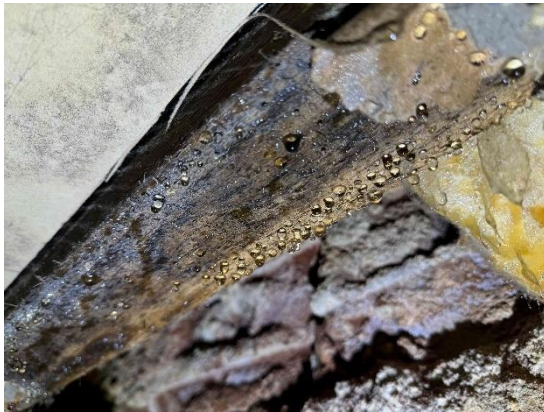
Condensation and decay to suspended timber floor joists

Improve ventilation to the suspended ground floor / cellar and replace the floor structure.

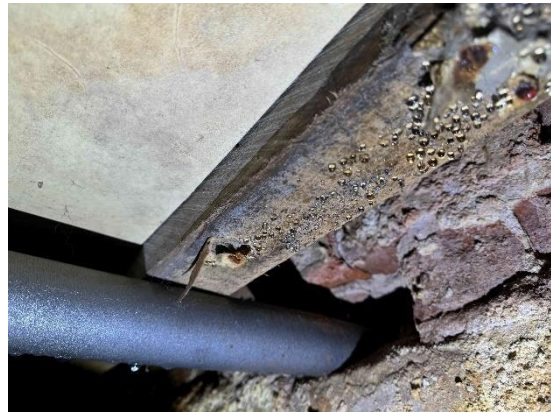
Condensation and decay to suspended timber floor joists

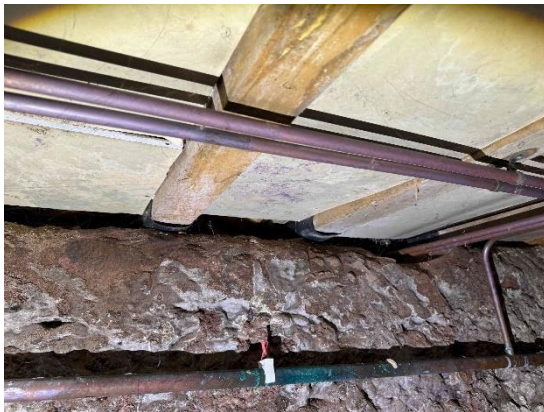
Mould noted to plasterboard between floor joists to secure insulation

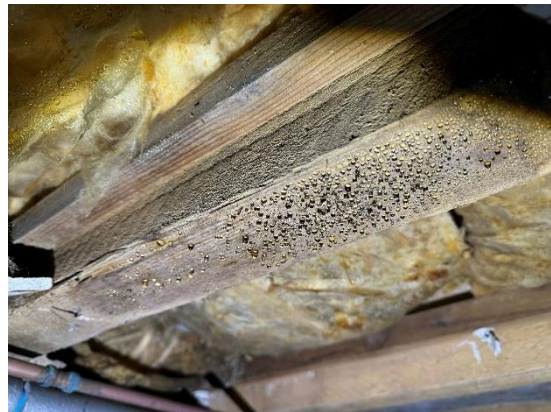
Condensation to suspended timber floor joists

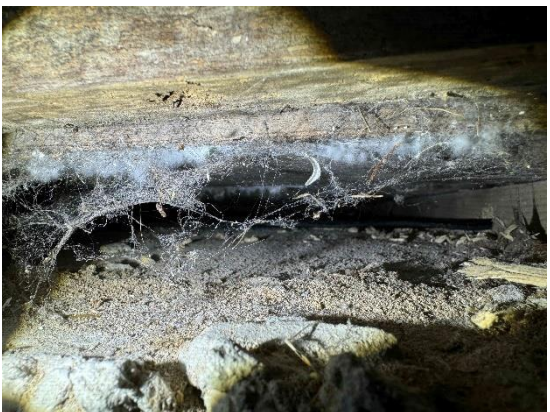
Mould noted beneath battened floor

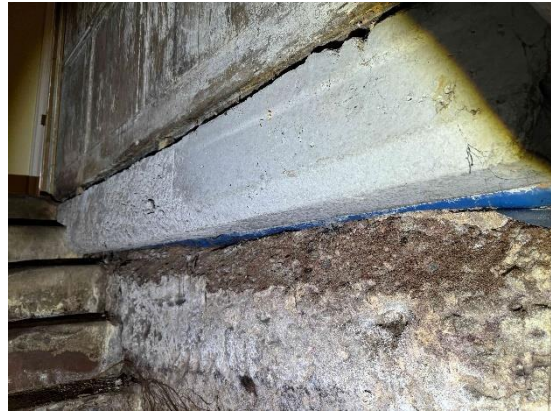
Evidence of new concrete floor with damp proof membrane

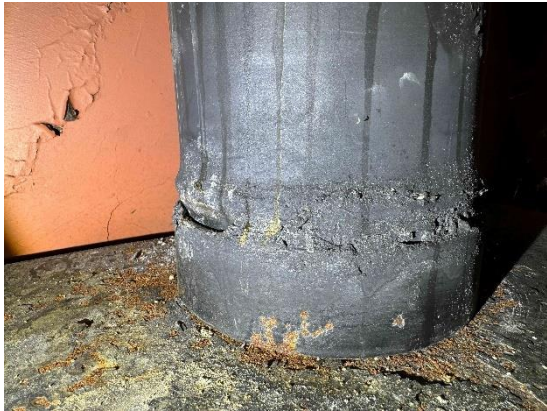
Defective flue in rear right hand side reception room

Replace the defective stoves.

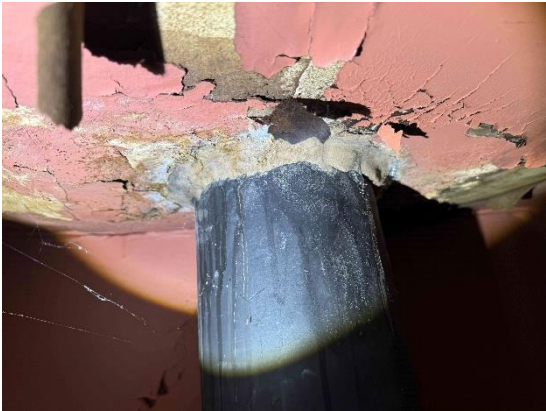
Damp and damaged boarding around flue in rear right hand side reception room

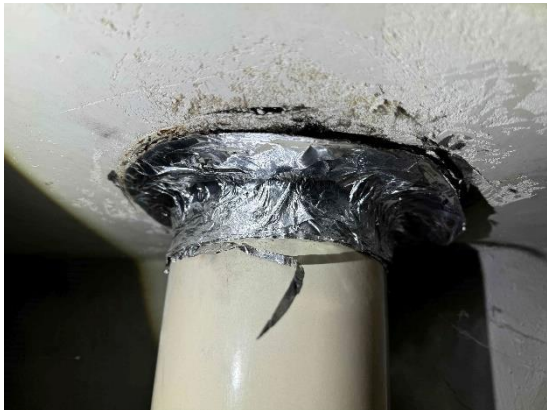
Defective DIY seals around flue in left hand side reception room

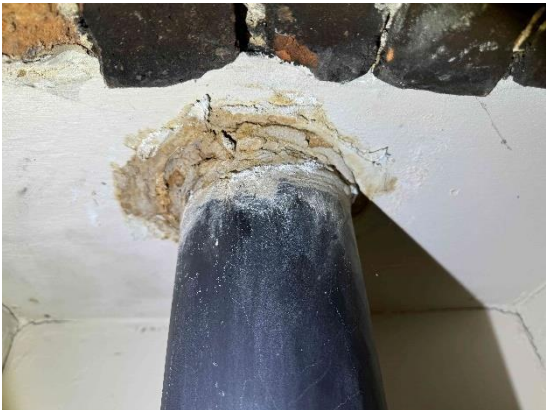
Defective flue seals in front middle bedroom

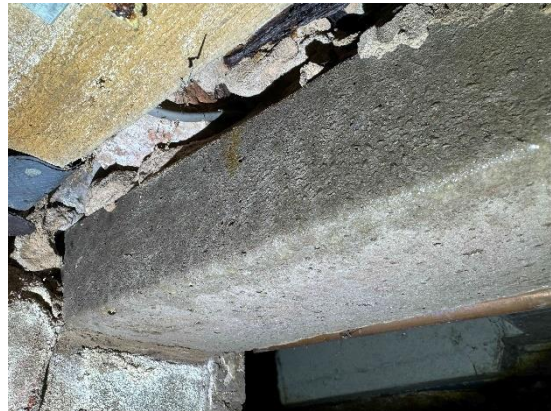
Condensation within cellar

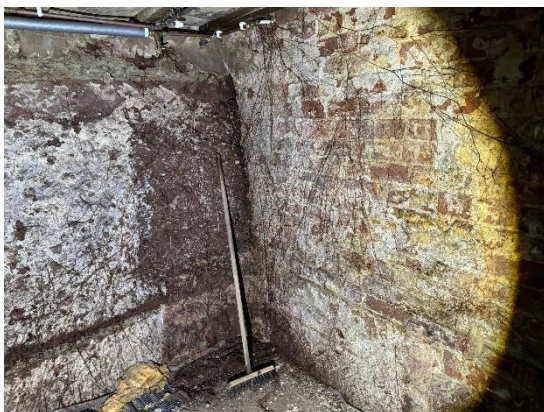
Rot within cellar

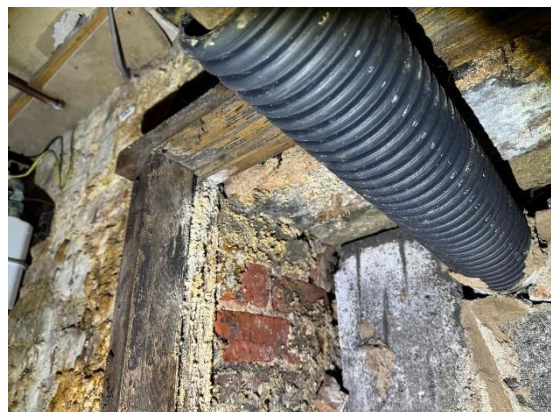
Decay to timber frame

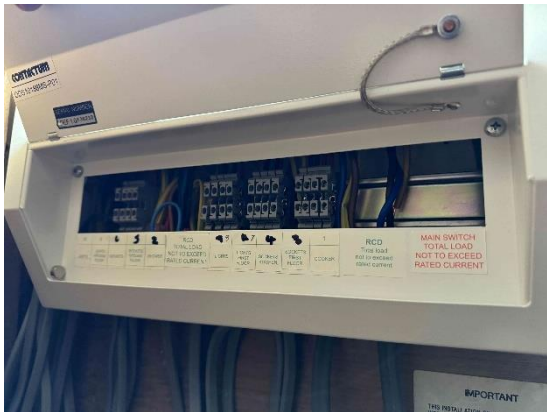
Main consumer unit bypassed with blanking plates missing

Inspect the electrical installation and carry out the recommended repairs.

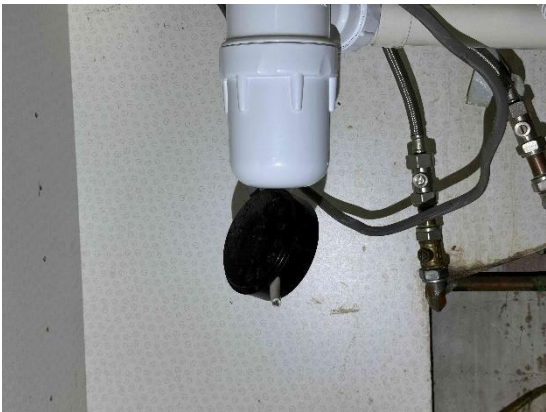
Loose and exposed cables in kitchen (may be redundant)

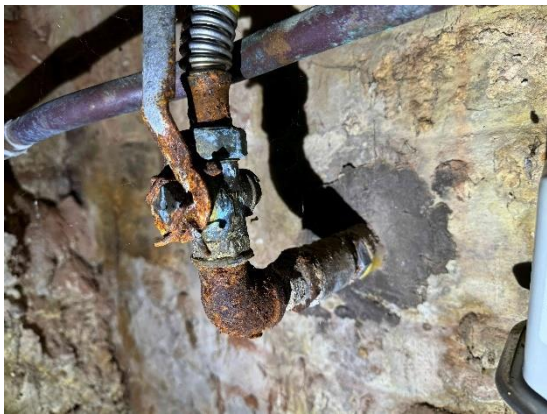
Corrosion to supply pipework

Replace the corroded pipework.

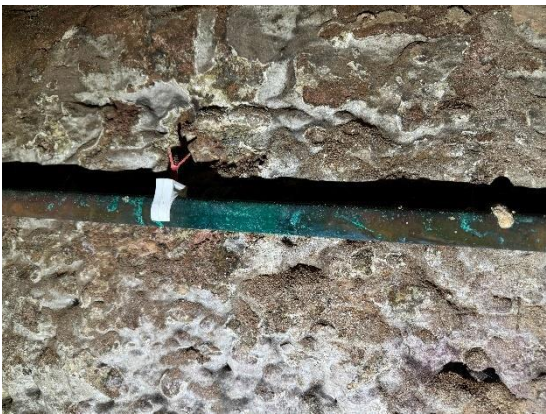
Corrosion to pipework

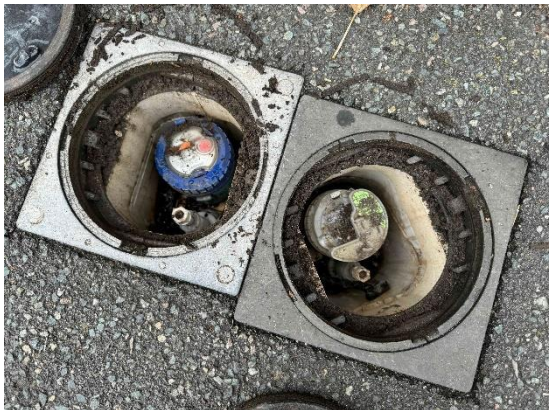
Confirmation should be sought as to which external stop tap and meter are connected to the subject property

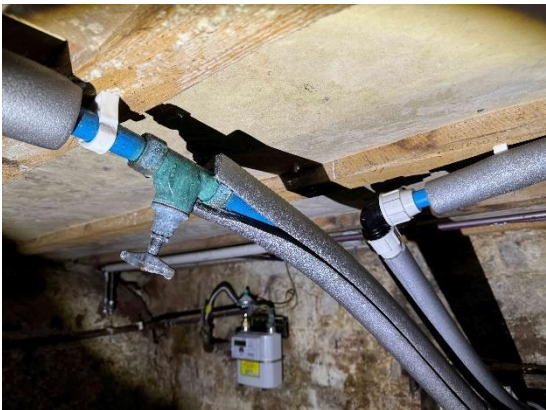
Internal stop tap and loose pipework

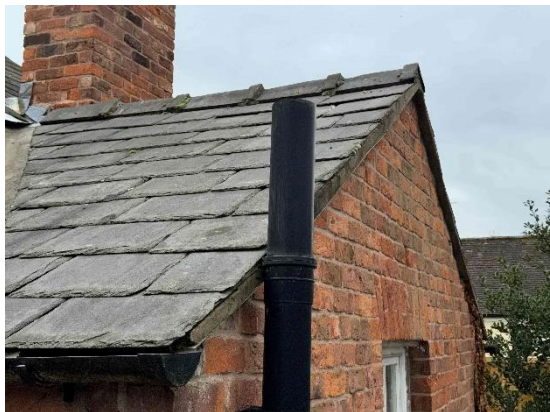
Open SVP

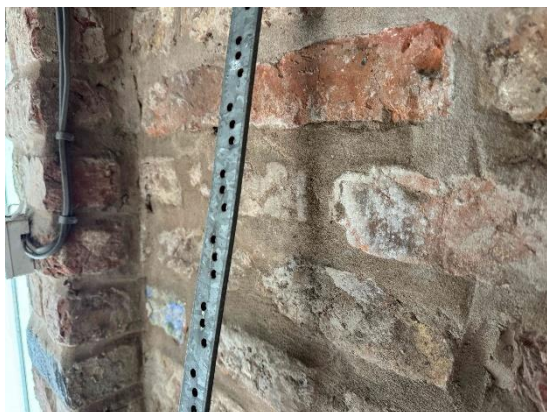
Loose wall plate strap

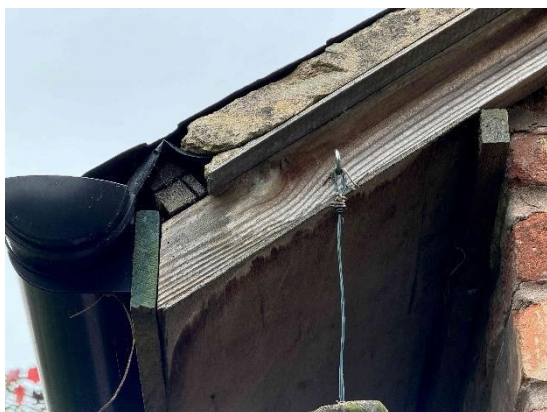
Missing mortar pointing to roof verge

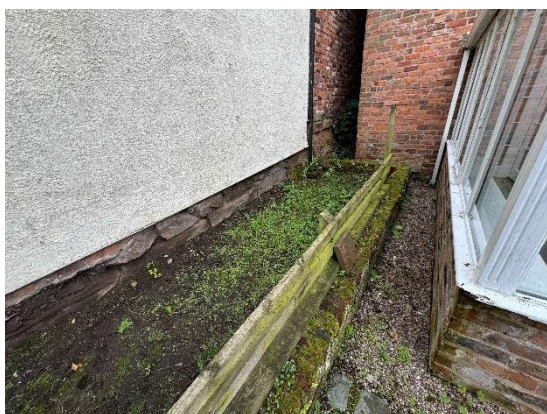
Confirmation that patch of land to rear belongs to the subject property or the property it is attached to
