LEVEL 3

# Your survey report

Level 3 Sample Report

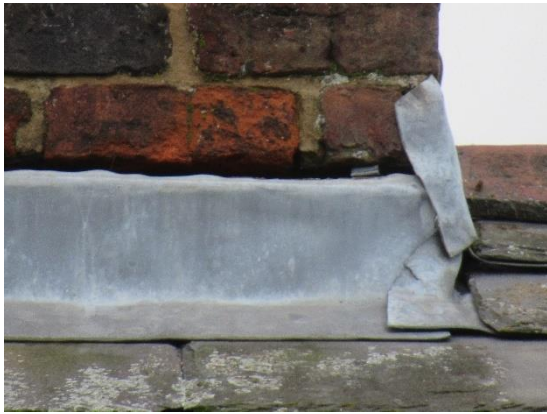
Gaps over flashings

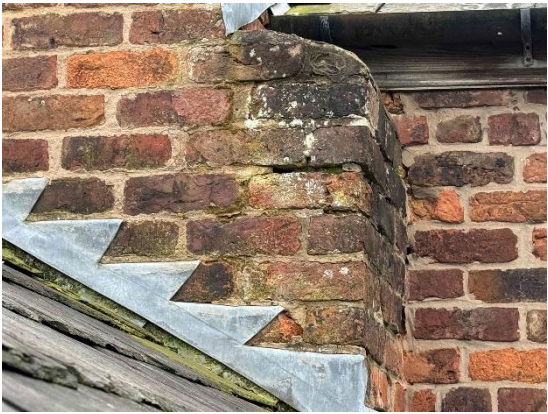
Perished mortar pointing

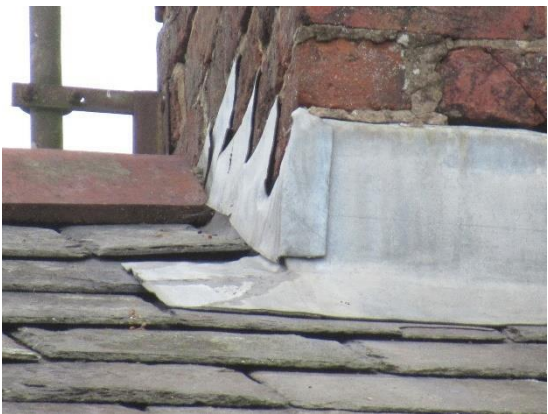
Gaps over flashings

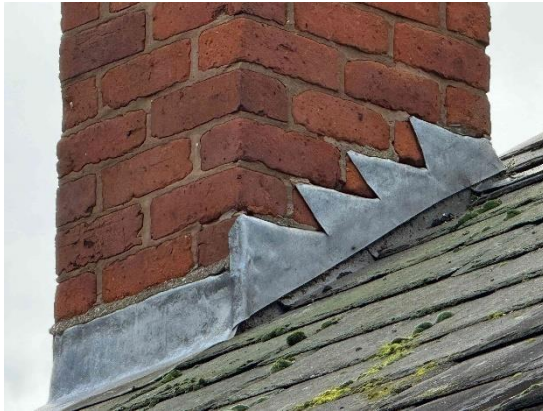
Gaps over flashings and perished mortar pointing

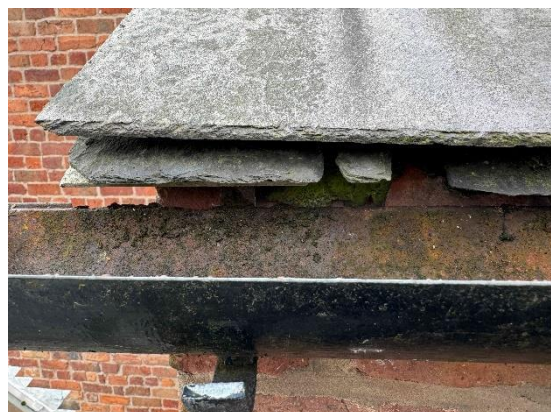
Underlay not lapping into gutter

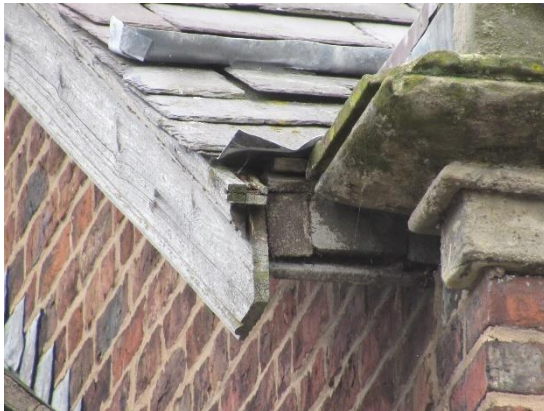
Poor detailing to front slope

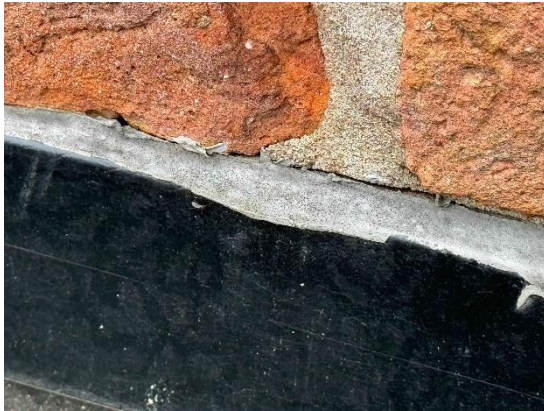
Gaps over rear extension flashings

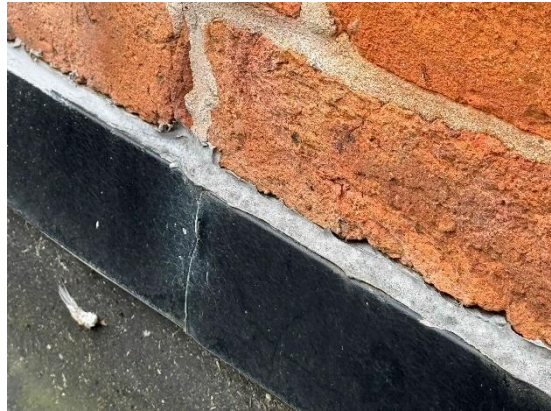
Gaps over rear extension flashings

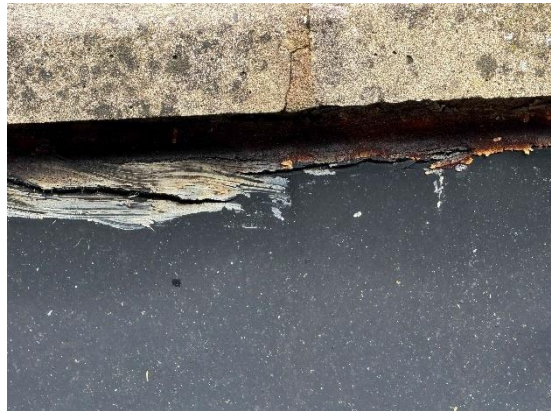
Gaps over rear extension upstand beneath coping stones

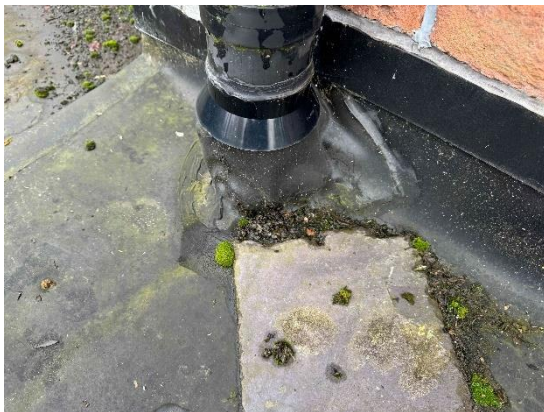
Slate to roof which could tear the covering

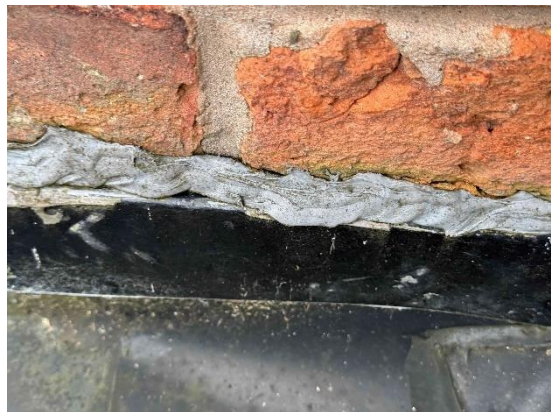
Gaps over rear extension flashings

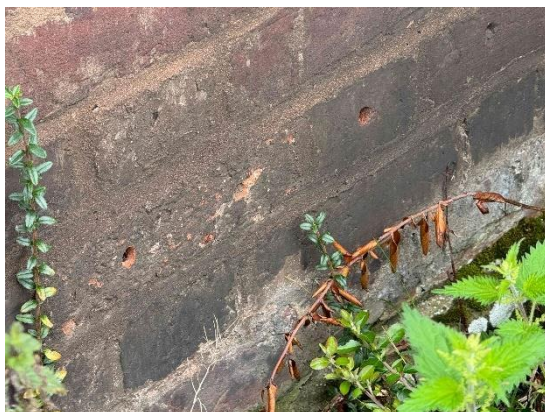
Remedial injected damp proof course

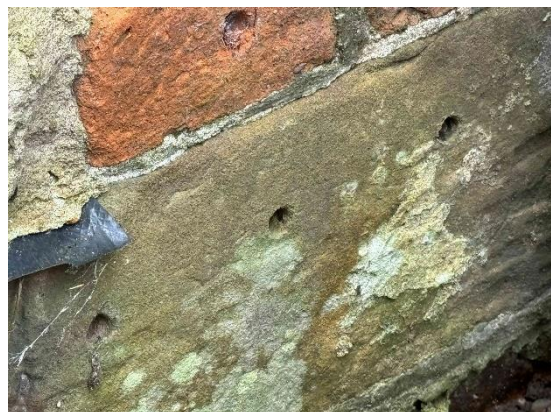
Remedial injected damp proof course

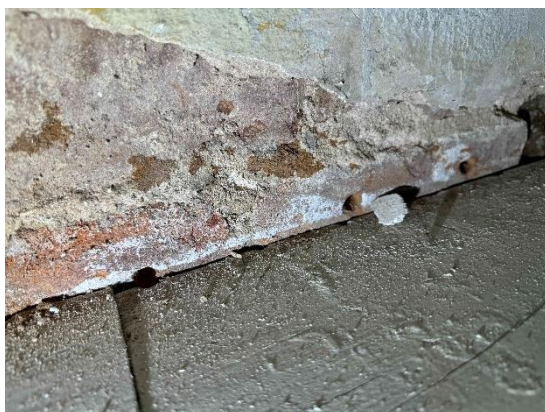
Remedial injected damp proof course

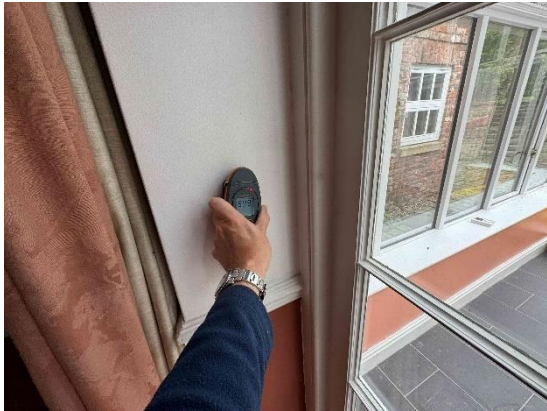
High damp meter readings at ground floor level

Remove damp plaster and carry out repairs. Reinststate plaster upon completion.

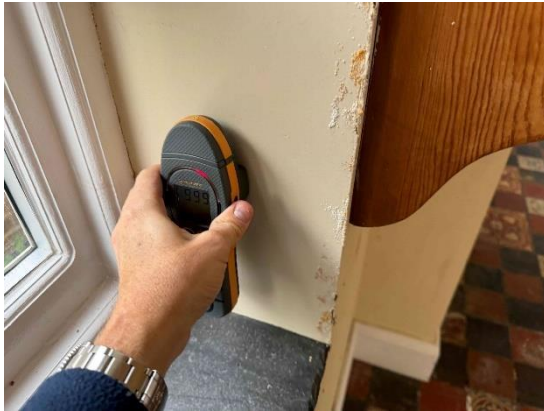
High damp meter readings and damaged plaster at ground floor level

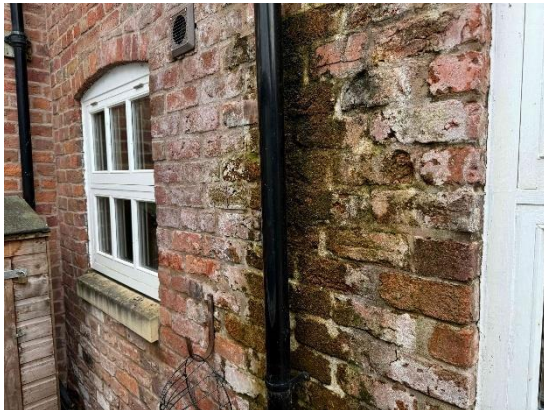
Stained brickwork and water ingress

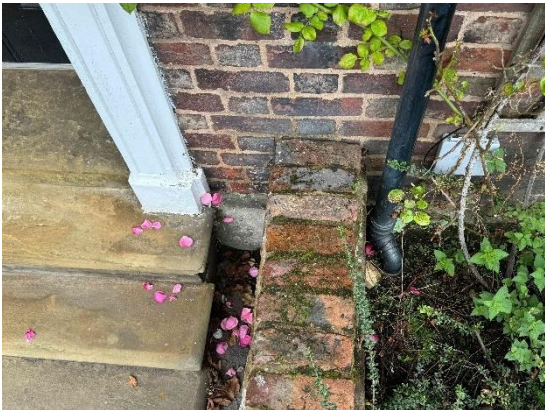
Front wall possibly bridging damp proof course

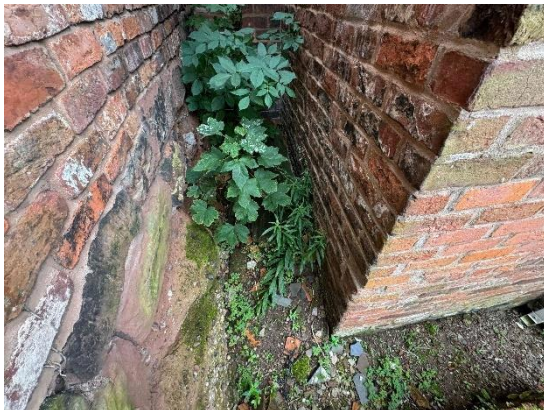
High ground level possibly bridging damp proof course

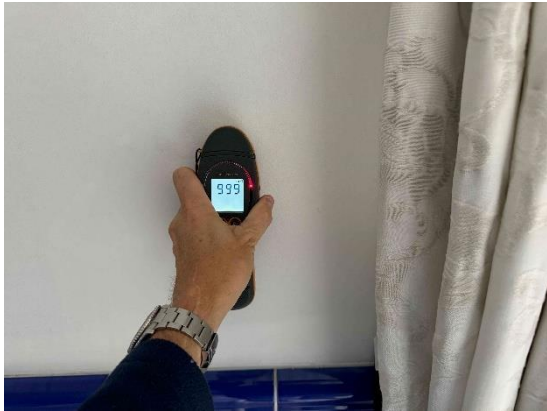
High damp meter readings at first floor level

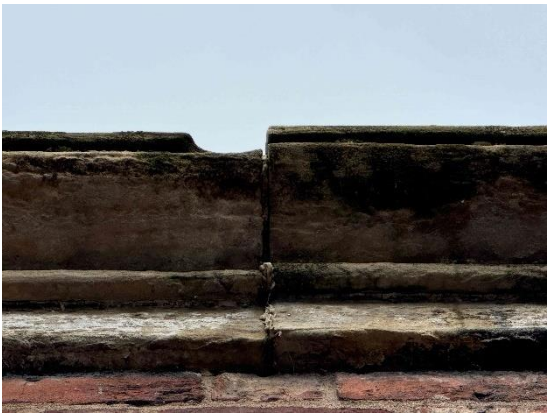
Gap in stonework and weathered stonework

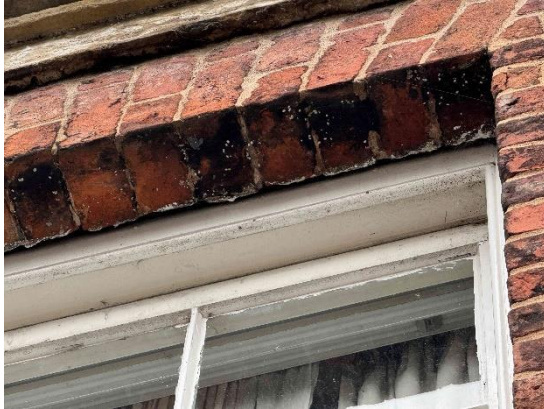
Gap over window opening

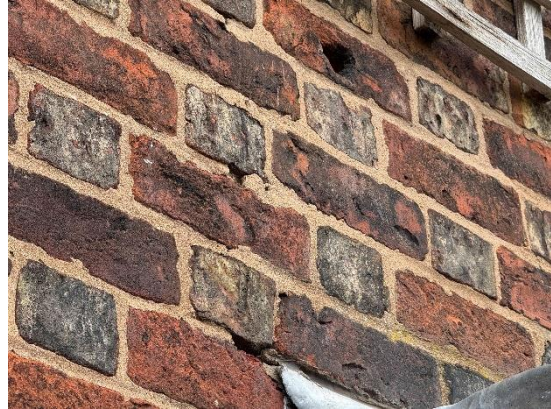
Gap in front wall and perished mortar pointing

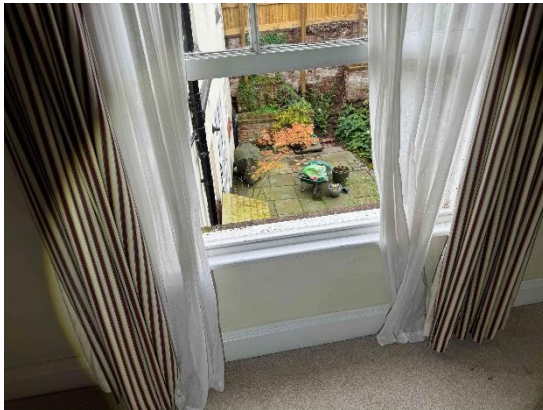
Safety concern with opening

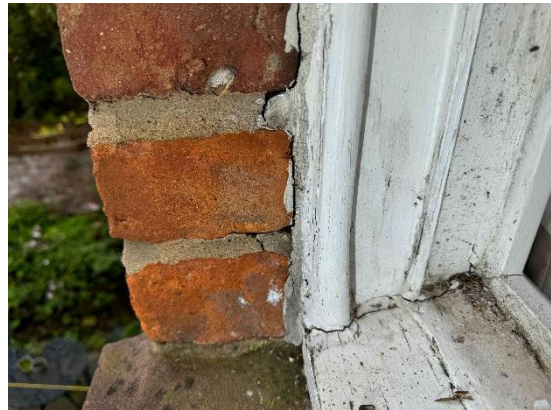
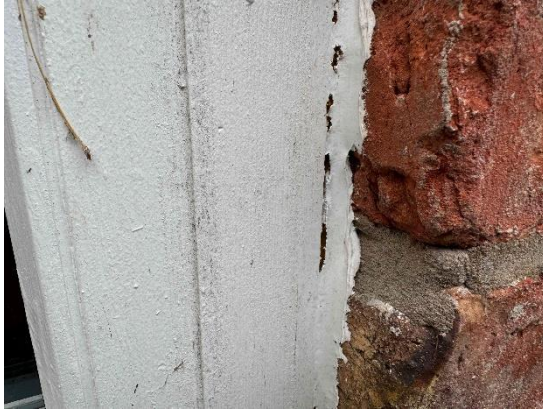
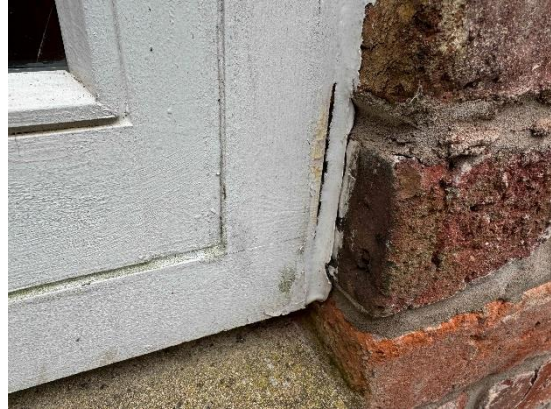
- Gaps were noted between the window frames and the surrounding masonry. This may have led to water ingress and needs replacing. I refer you to my comments in Section D4 Main walls in this regard.
- The original windows are at a limited height above the floor and this makes them a potential safety risk. You should fit restricting stays to reduce the risk of falling through the openings.
- Evidence of decay was noted to the original windows. The affected areas should be spliced repaired or the windows should be replaced.

Gaps between frame and wall

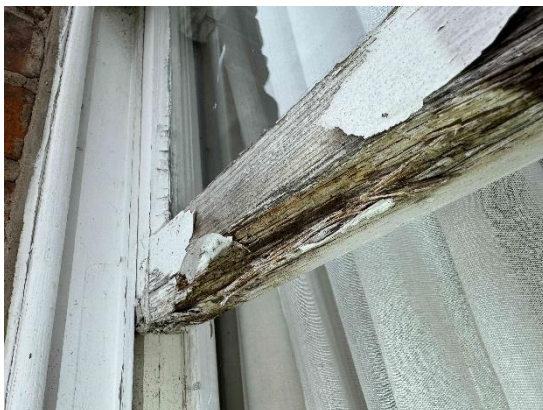
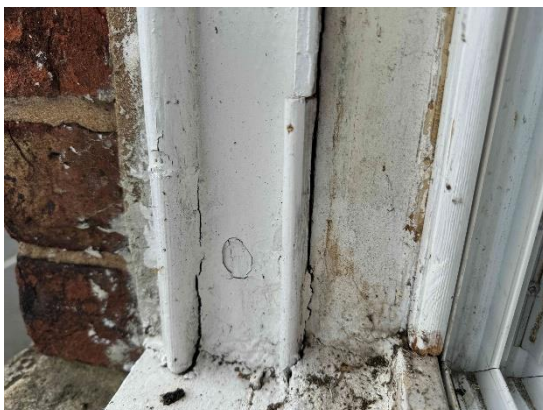
Decay to window

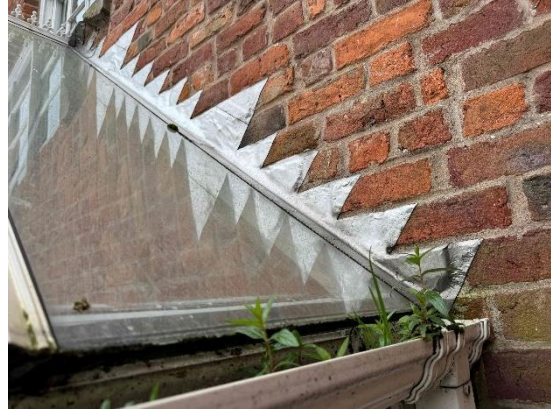
DIY self-adhesive flashings and vegetation in gutter

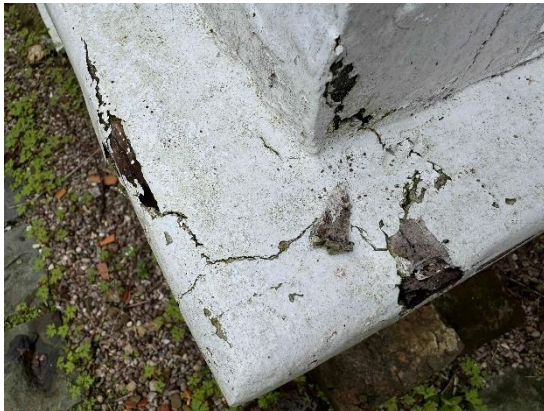
Decay to conservatory

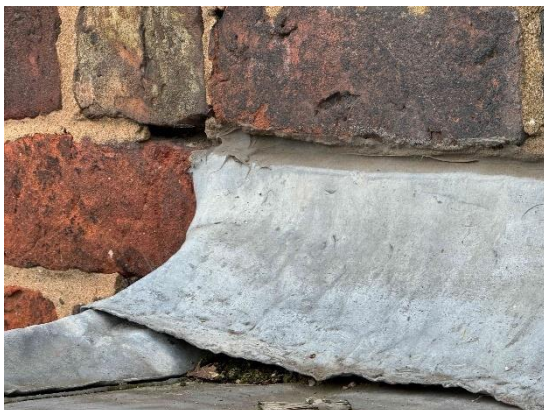
- The flashings don't extend beyond the canopy and there are gaps around them. In addition they don't lap into the hopper. The flashings should be replaced.
- Evidence of corrosion was noted to the hopper and it was noted to be loose. The hopper should be prepared, treated and coated to ensure it is suitably protected to prevent further deterioration. In addition it should be secured.

Flashings don't extend beyond the canopy and gaps around flashings

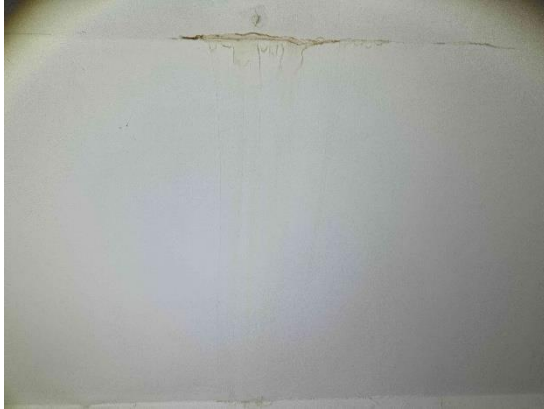
- Evidence of staining was noted to the ceiling in the bathroom and I recorded damp meter readings here. The pattern of damp would indicate the most likely cause to be as a result of water ingress via the roof covering.

Staining to ceiling in bathroom

Repair is required of the roof covering and I refer you to my comments in Section D2 Roof coverings in this regard. Additional repairs to the roof timbers are likely and the ceiling finishes should be removed to enable a thorough inspection from below prior to exchange of contracts.

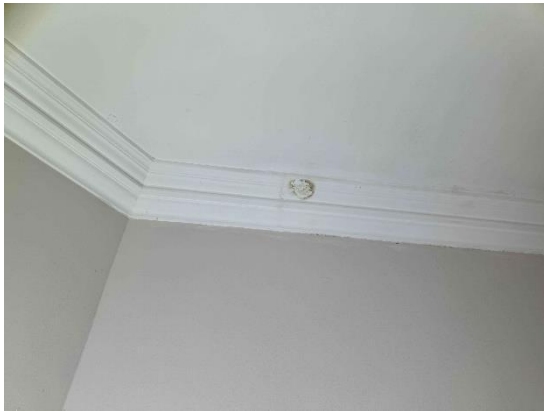
Staining in front right hand side reception room beneath right hand side ensuite

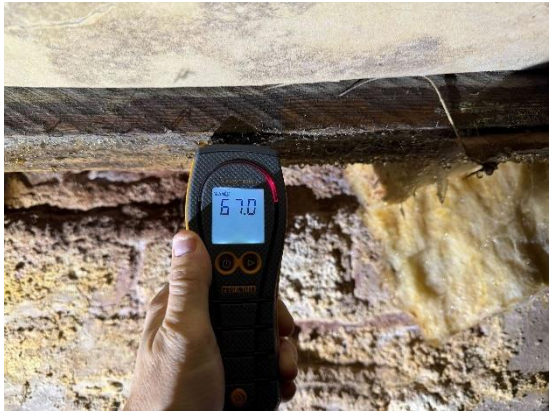
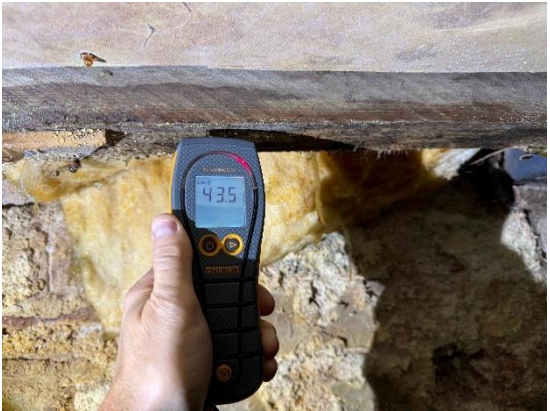
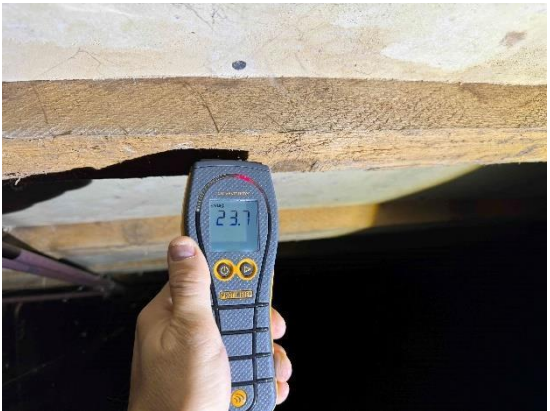
High damp meter readings to floor joists

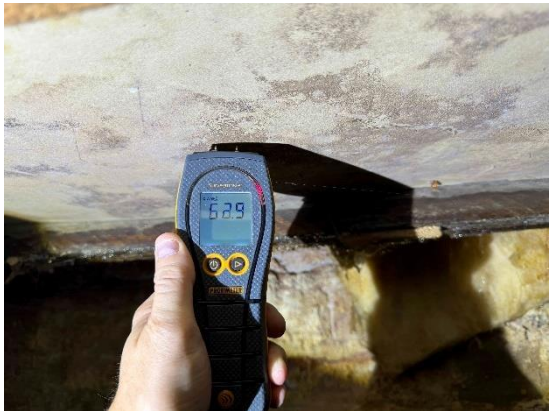
High damp meter readings to plasterboard between floor joists

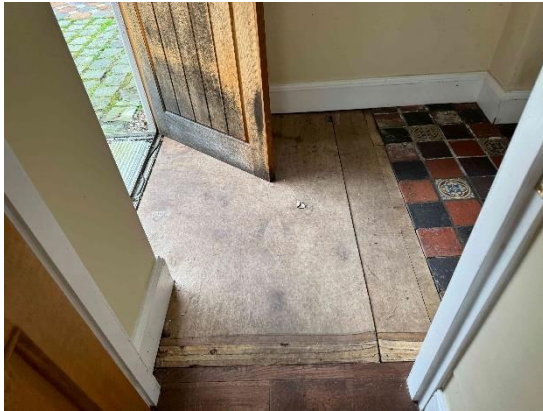
Missing floor covering and loose boards to rear hallway

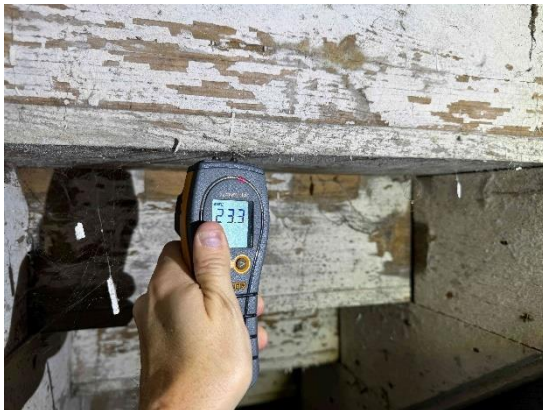
High damp meter readings to underside of staircase

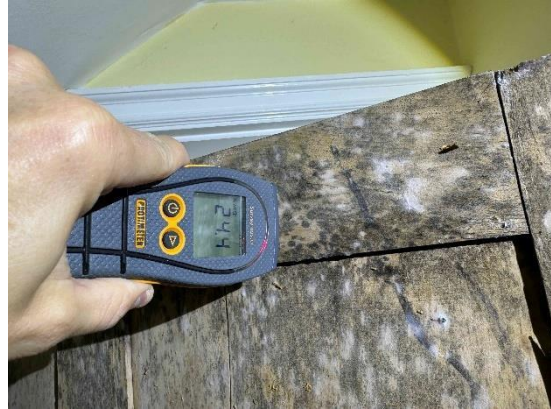
High damp meter readings to entrance door

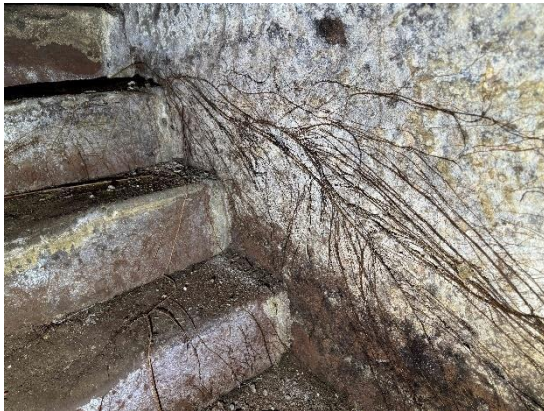
Rot within cellar

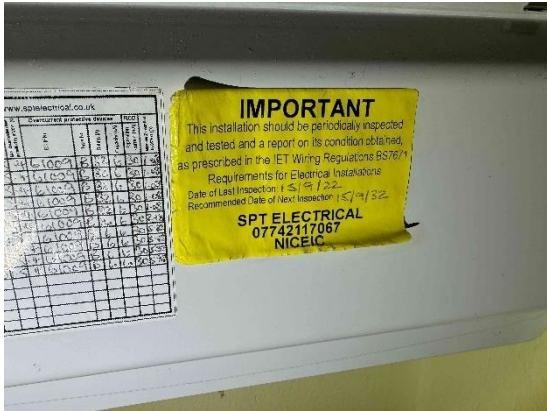
Sticker on the second consumer unit states that an inspection was carried out on the 15th September 2022, stating that another inspection should be carried out before 15th September 2032

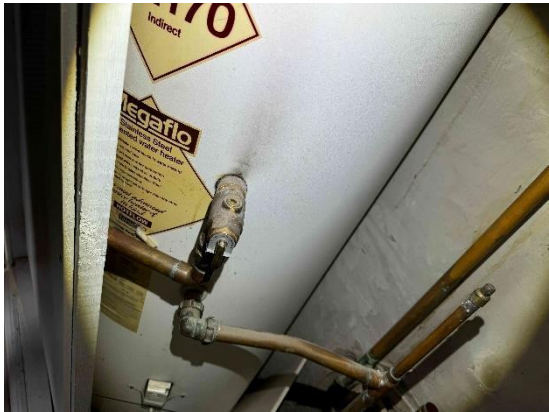
Hot water cylinder

It should be noted that hot water flow depends on cold water mains pressure, in the event that the cold water goes off you will also loose hot water.

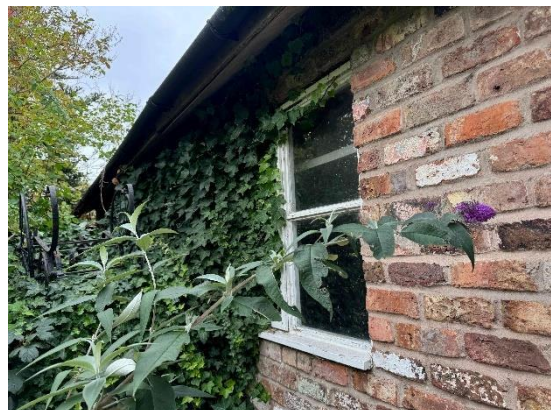
- Several defects were noted including:-
  - loose wall plate strap internally,
  - corrosion to the window lintel,
  - missing mortar pointing to the roof verge,
  - gaps around the rear door frame,
  - and vegetation growth to the rear elevation,

Vegetation growth blocking rear of garage

Repairs are required of these items to reduce the risk of future defects developing.

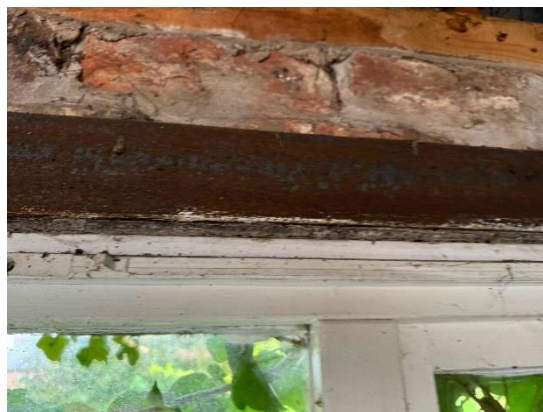
Corrosion to lintel

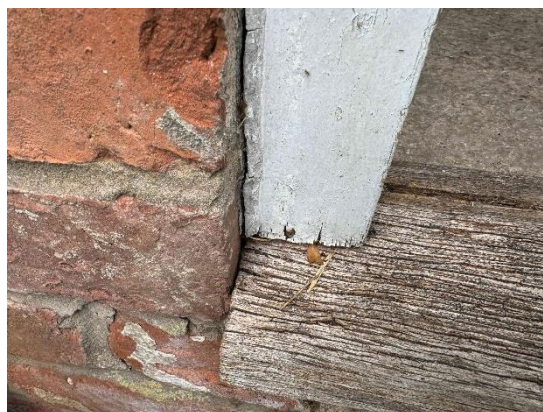
Gaps around door frame
