LEVEL 3

# Your survey report

Level 3 Sample Report

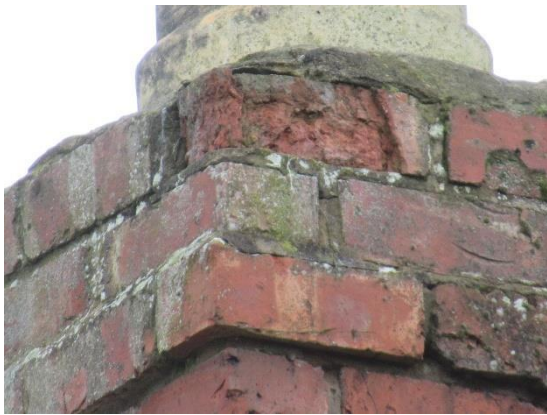
Weathered masonry

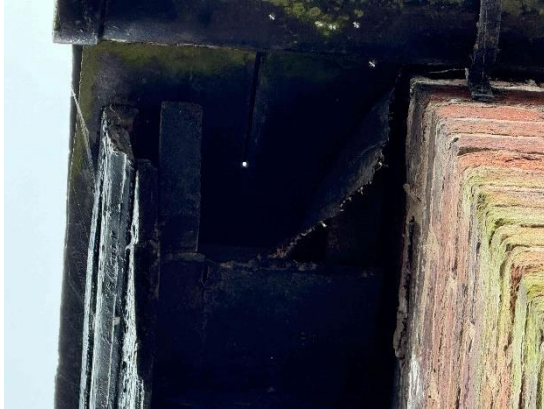
Underlay damaged

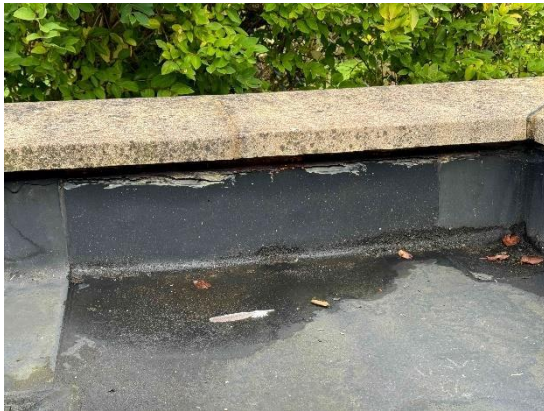
Gaps over rear extension upstand beneath coping stones

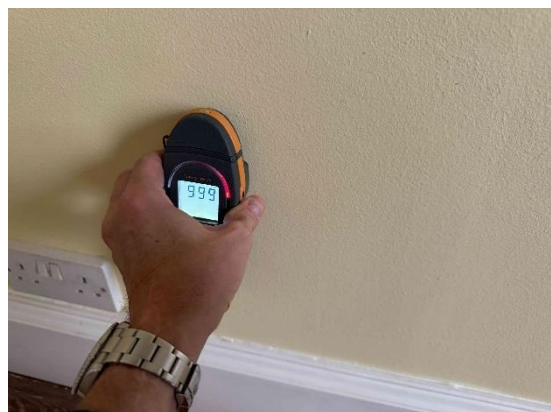
High damp meter readings at ground floor level

Remove damp plaster and carry out repairs. Reinststate plaster upon completion.

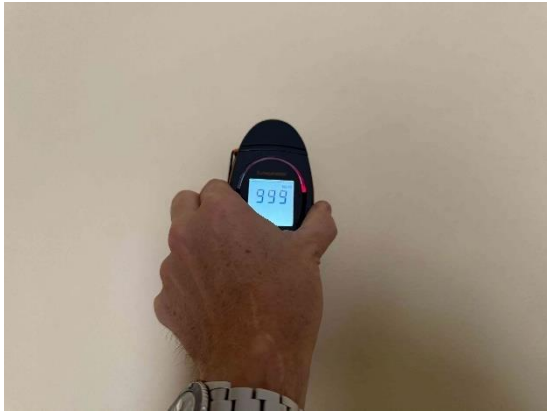
High damp meter readings at ground floor level

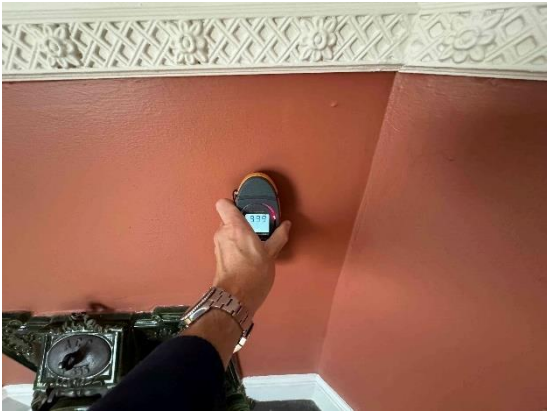
High damp meter readings at ground floor level

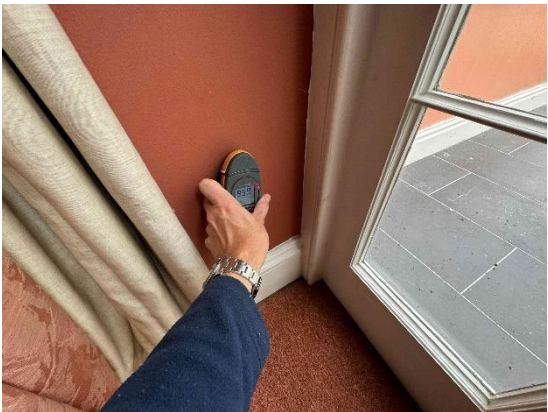
High damp meter readings at ground floor level

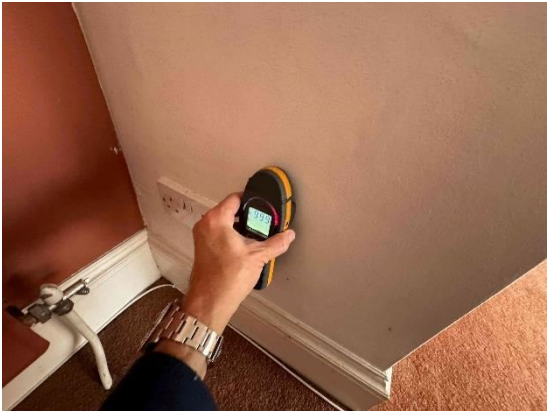
High damp meter readings at ground floor level

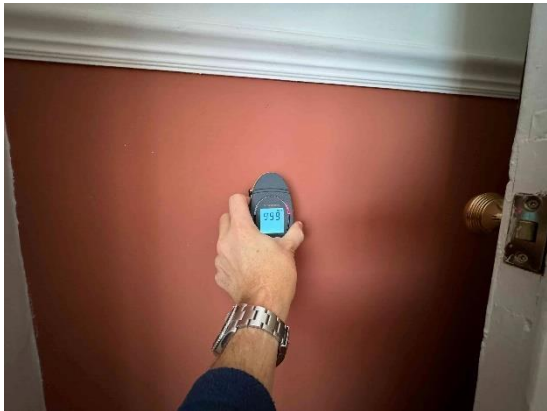
High damp meter readings at ground floor level

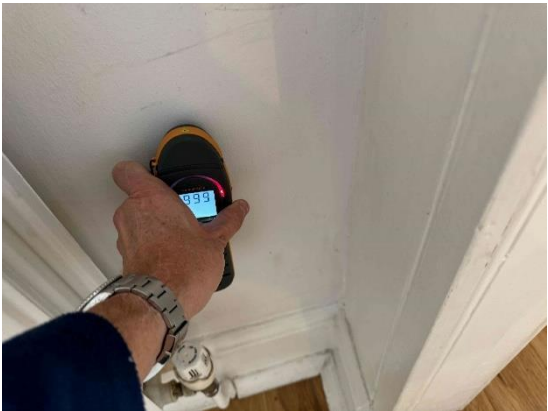
High damp meter readings at ground floor level

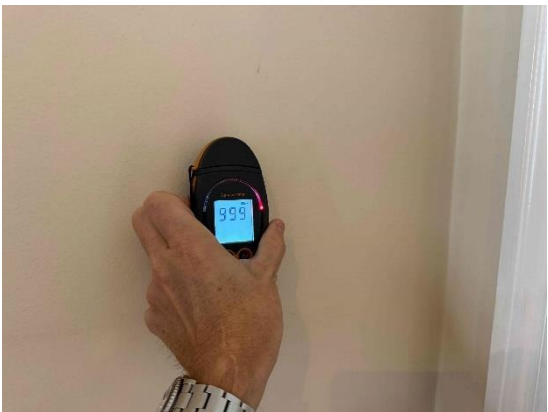
High damp meter readings at ground floor level

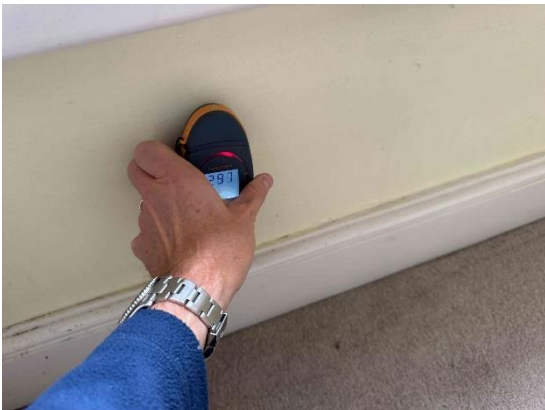
High damp meter readings at first floor level

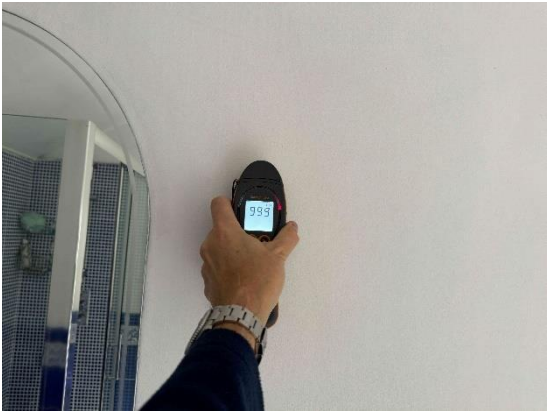
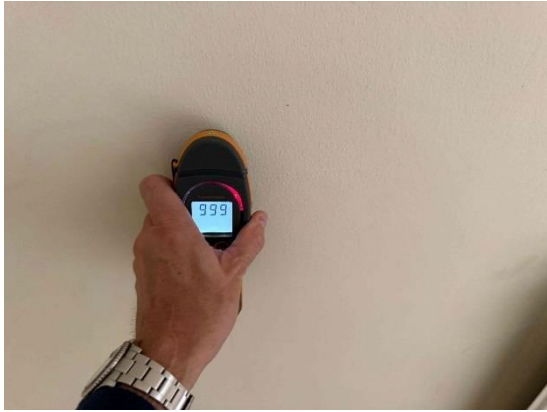
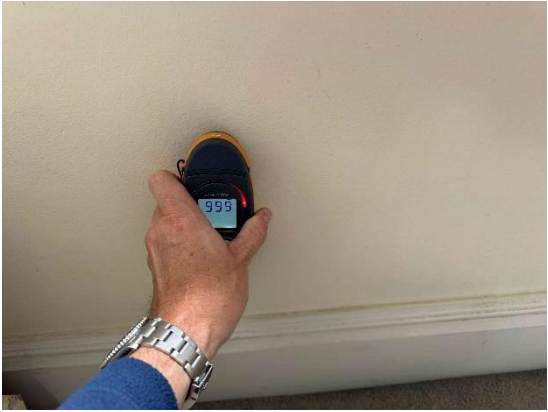
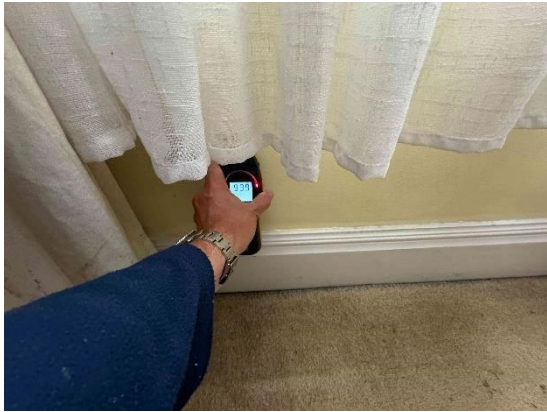
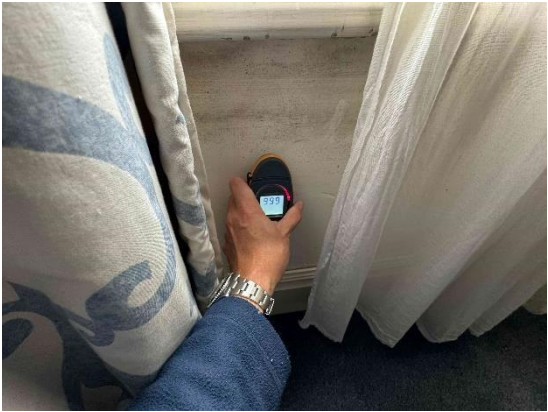
High damp meter readings at first floor level

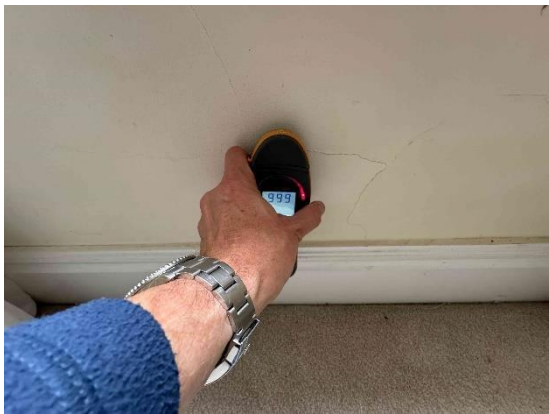
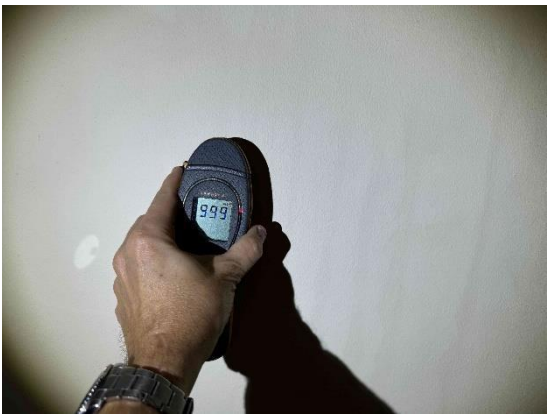
High damp meter readings at first floor level

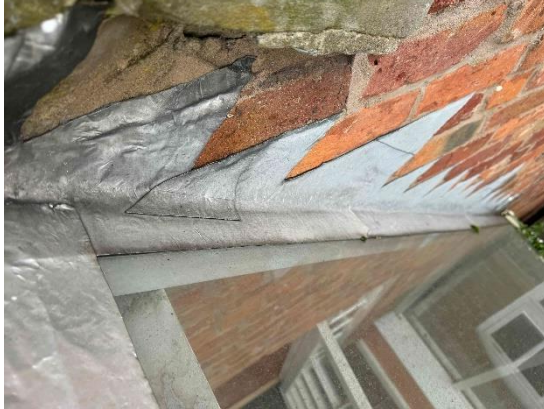
- Several defects were noted including:-
  - decay to the frame,
  - DIY temporary self-adhesive flashings,
  - splits in the DIY temporary self-adhesive repairs,
  - misted glazing,
  - and vegetation growth in gutter.

DIY self-adhesive flashings

Numerous aspects of the conservatory are defective. The costs to undertake the highlighted repairs will be significant and it may be more cost effective to completely remove it and replace with new. Permission may be required and you should check with the Local Authority Planning Department before undertaking any such work.

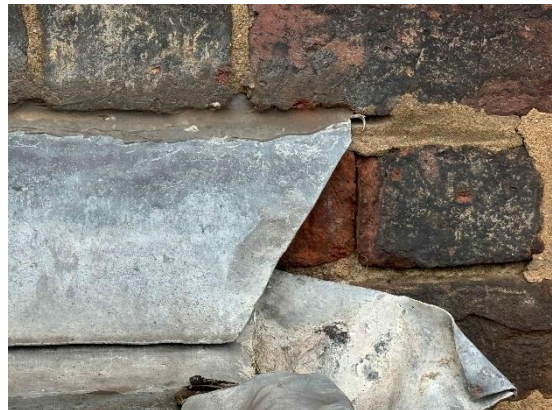
- The flashings don't extend beyond the canopy and there are gaps around them. In addition they don't lap into the hopper. The flashings should be replaced.
- Evidence of corrosion was noted to the hopper and it was noted to be loose. The hopper should be prepared, treated and coated to ensure it is suitably protected to prevent further deterioration. In addition it should be secured.

Flashings don't extend beyond the canopy and gaps around flashings

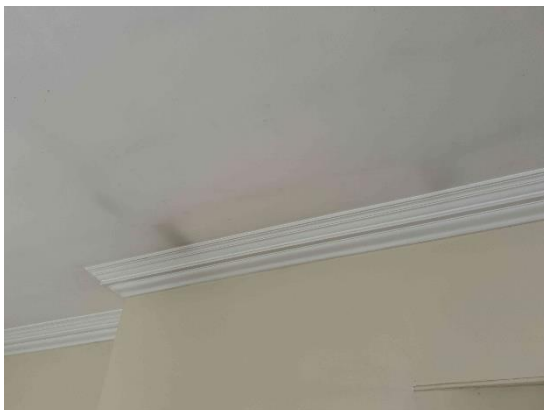
Black staining

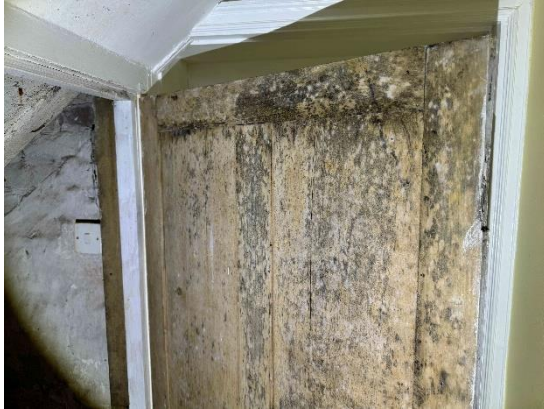
Mould to entrance door

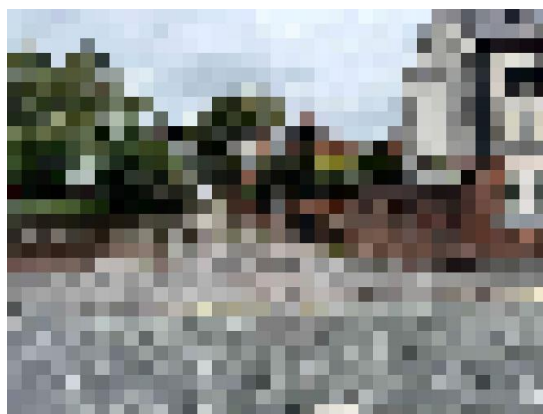
Access to the rear garden via the private driveway
